MODEL  
2014~2016MY  
Sportage (SL)  
2014~2015MY  
Optima (QF)

NUMBER  
092 (REV 1, 02/29/2016)

## TECHNICAL SERVICE BULLETIN

SUBJECT: SIRIUS AUDIO MUTES (DROPS OUT) INTERMITTENTLY  
IN OPEN SPACES

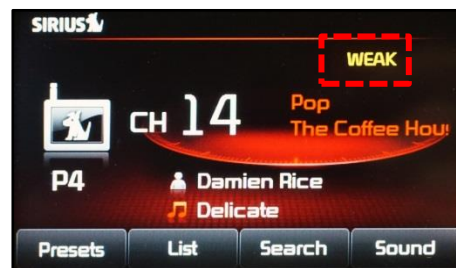
This bulletin provides information about the replacement of the shark-fin style roof antenna of some 2014~2016MY Sportage (SL) vehicles, produced from August 1, 2014 through August 31, 2015, and some 2014~2015MY Optima (QF) vehicles, produced from August 1, 2013 through August 22, 2015, which may exhibit Sirius audio reception concerns (see sample complaints below). Follow the procedure outlined in this bulletin to replace the roof antenna and correct the concern.

- 1- Satellite radio has weak or no signal frequently while driving
- 2- Sirius radio reception cuts in and out often and/or drops out (muting). **NOTE: this condition can occur for time periods longer than 1-2 seconds.**

1. Replace the antenna with an improved one by referring to “Body Electrical System→ Audio→ Antenna→ Repair procedures” chapter in the applicable Workshop Manual.
