NUMBER: 23-030-16

GROUP: Body

Low Spots In Roof At Left Or Right Rear Corners Of The Panoramic Sunroof Opening

2015 (LX) Chrysler 300

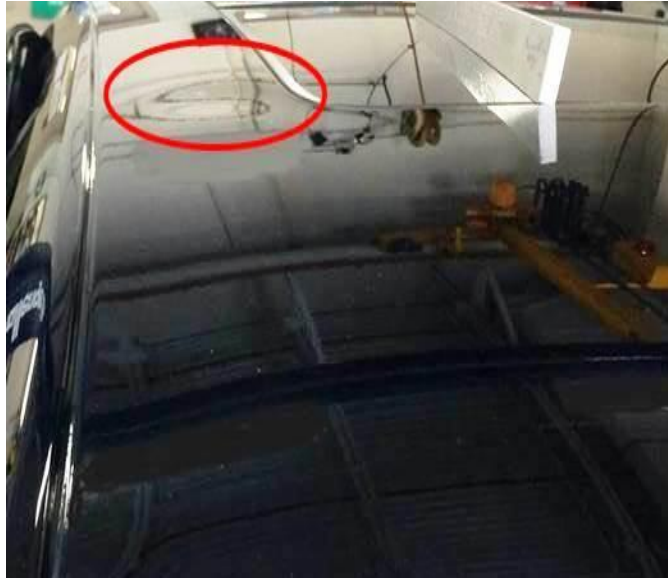
Fig. 1 Low Spot

Customers may identify low spots at the left or right rear corners near the dual pane panoramic sunroof opening at the outer roof panel surface (Fig. 1). The issue may appear more pronounced on dark colored vehicles.
