NUMBER: 23-034-16

Left Front Door Rattle

2017 (RU) Chrysler Pacifica

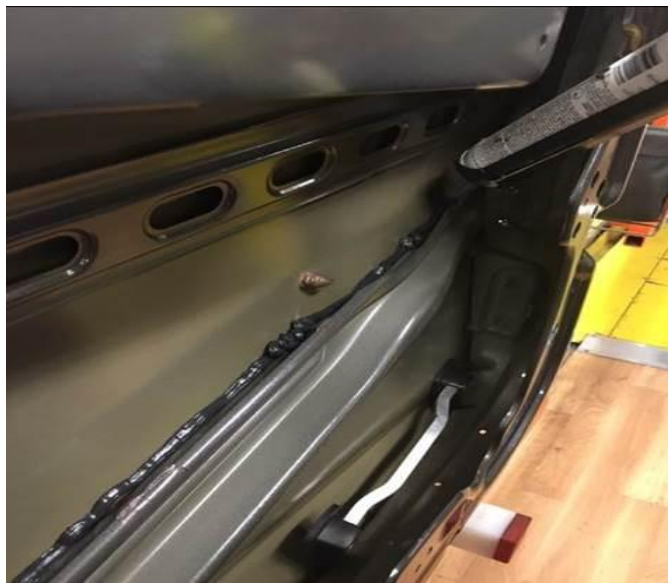
Fig. 1 Apply Urethane

1. Remove carrier plate to gain access to inner door. Refer to the detailed service procedures available in DealerCONNECT> TechCONNECT under: Service Info> 23 - Body> Door - Front> Plate, Carrier> Removal.
2. Apply bead of adhesive between impact beam and door outer panel adjacent to existing anti-flutter bead (Fig. 1). Ensure urethane wets out on both sides of sheet metal and does not wet out against anti-flutter. The length of existing anti-flutter bead may be used to determine length required.

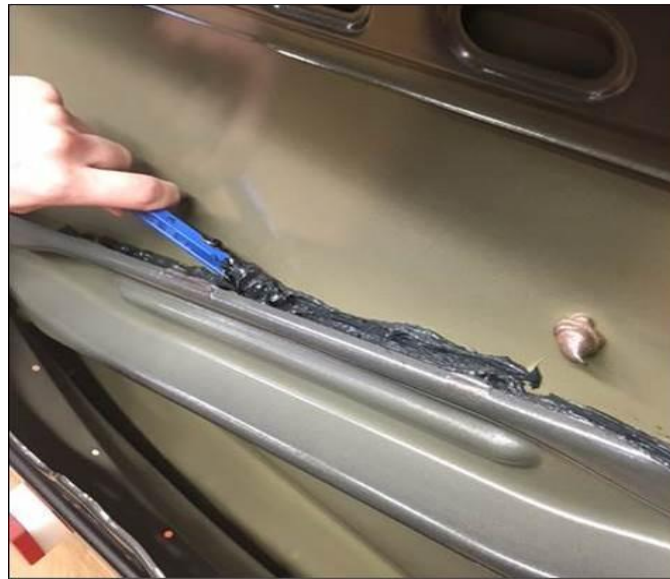
Fig. 2 Use Trim Stick To Force Into Space

- 3. Using a trim stick or equivalent tool, press the urethane bead down to ensure wet out on both sides (Fig. 2).
