Service Bulletin

PRELIMINARY INFORMATION

Subject: Supplement to Bulletin 06-06-01-017 - User Tips for EN48464

Models: 2004-2007 Buick Rainier
2002-2007 Chevrolet Trailblazer
2004-2007 Chevrolet Colorado
2002-2007 GMC Envoy
2004-2007 GMC Canyon
2002-2004 Oldsmobile Bravada
2006-2007 HUMMER H3
2005-2007 Saab 9-7X
With any of the following engines:
2.8L (VIN 8 - RPO LK5)
2.9L (VIN 9 - RPO LLV)
3.5L (VIN 6 - RPO L52)
3.7L (VIN E - RPO LLR)
4.2L (VIN S - RPO LL8)

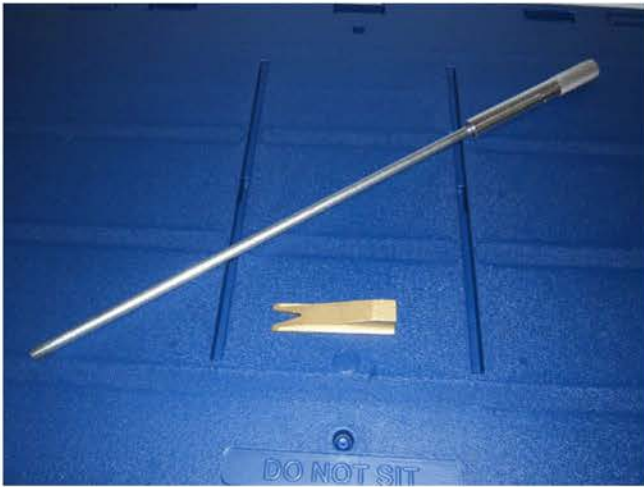
1. Thoroughly review the latest version of 06-06-01-017 before the cylinder head replacement process is started.
2. Before using the tool, make sure that the tool handle and threaded rod unscrew from the wedge as shown below.

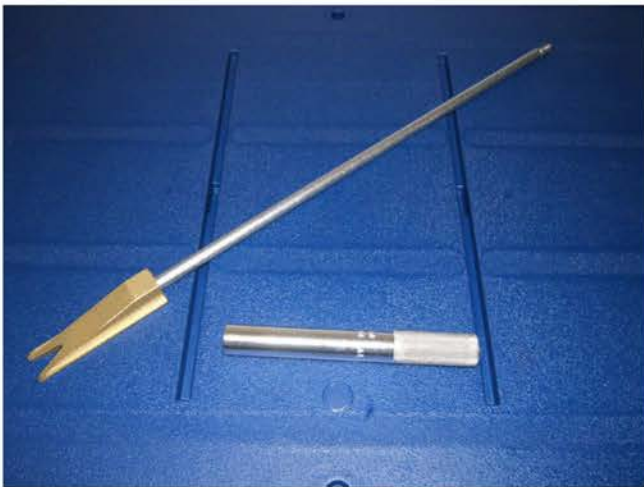
If the tool handle unscrews from the threaded rod, leaving the threaded rod screwed into the wedge as shown below, apply thread locker to the threads of the tool handle and screw it onto the threaded rod to prevent it from coming off in the future.

This should be done before replacing the cylinder head by following the latest version of 06-06-01-017.

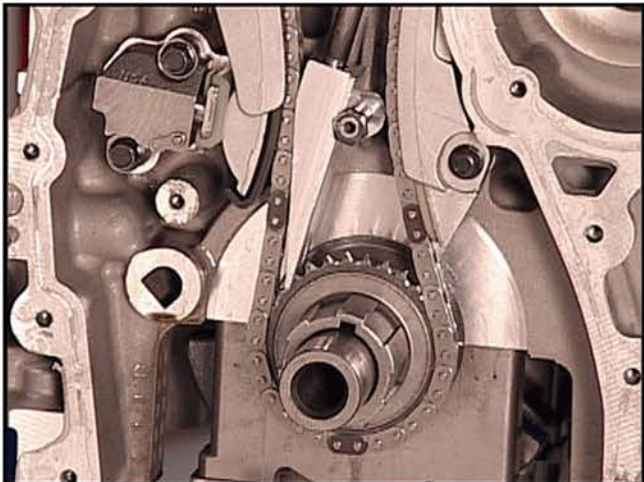
3. When inserting the wedge, ensure that it is installed in the correct direction as shown below.
