Service Bulletin

PRELIMINARY INFORMATION

Subject: Rough Idle In Drive

Models: 2015-2016 Cadillac Escalade Models
2014 Chevrolet Silverado 1500
2015-2016 Chevrolet Silverado 1500, Suburban, Tahoe
2014 GMC Sierra 1500
2015-2016 GMC Sierra 1500, Yukon Models
With engines 4.3L, 5.3L, 6.2L RPO L83, L86, LV1, LV3

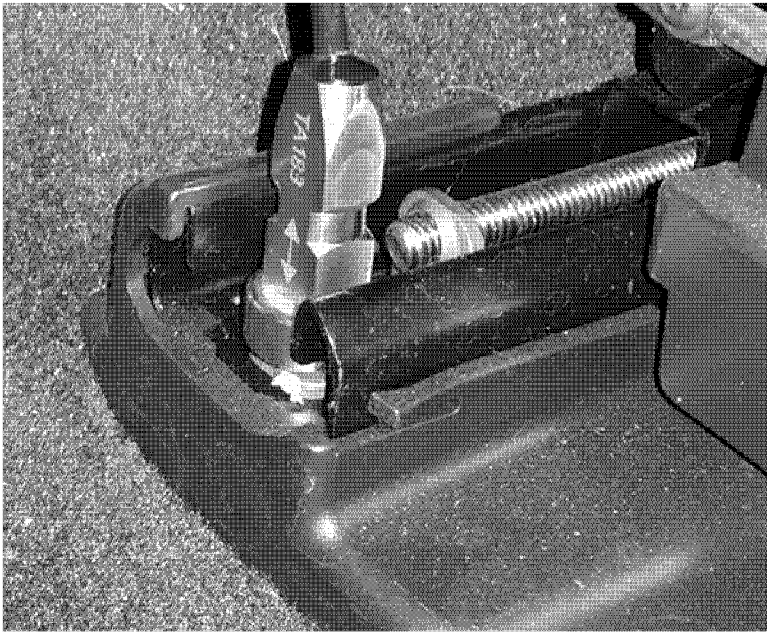
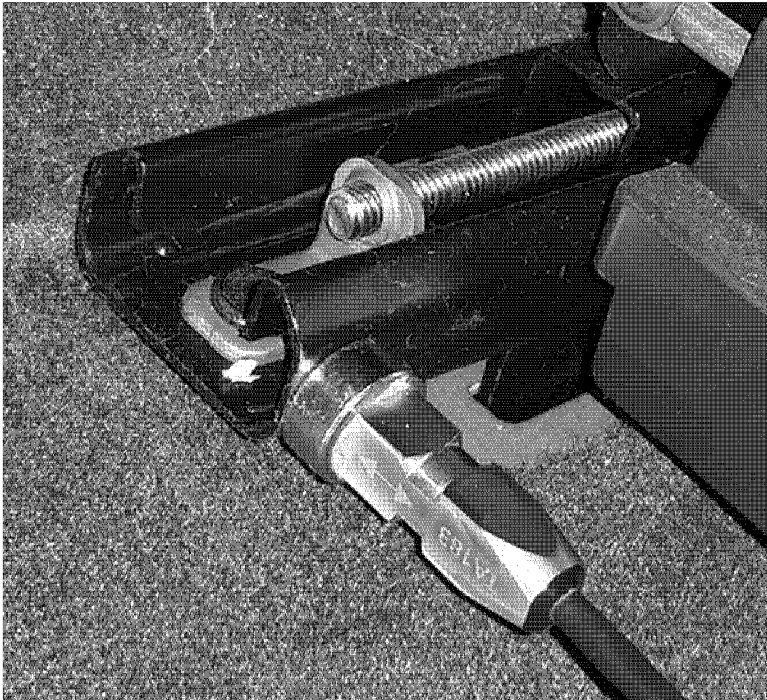
Note: If using a single-axis pico sensor, mount and test both vertically and horizontally – E1.5 rough idle vibration will usually be horizontal / lateral at the seat track.

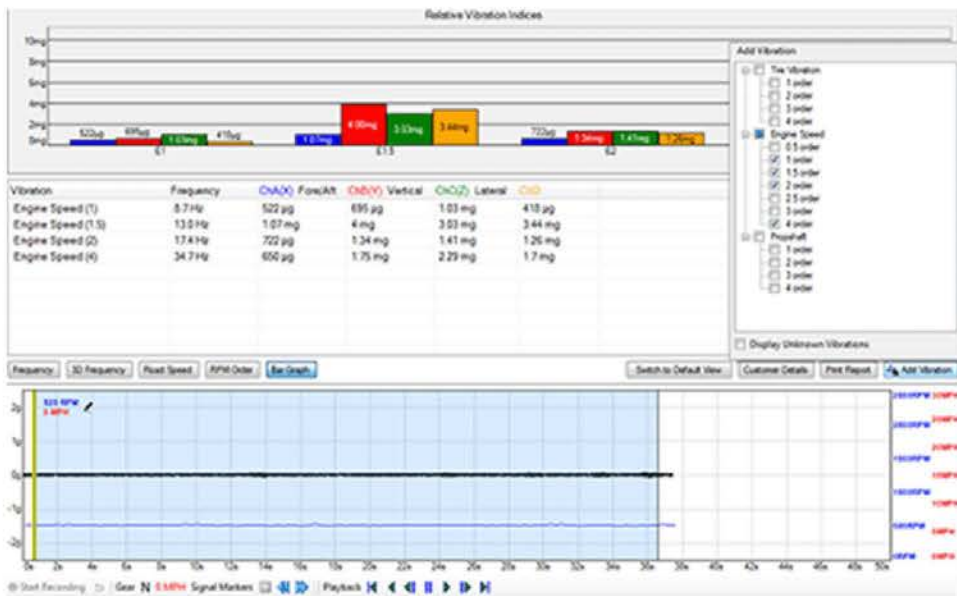
Add E1.5 to the displayed data and turn off T and P related data (under Add Vibration in Pico) since issue occurs with vehicle stationary.

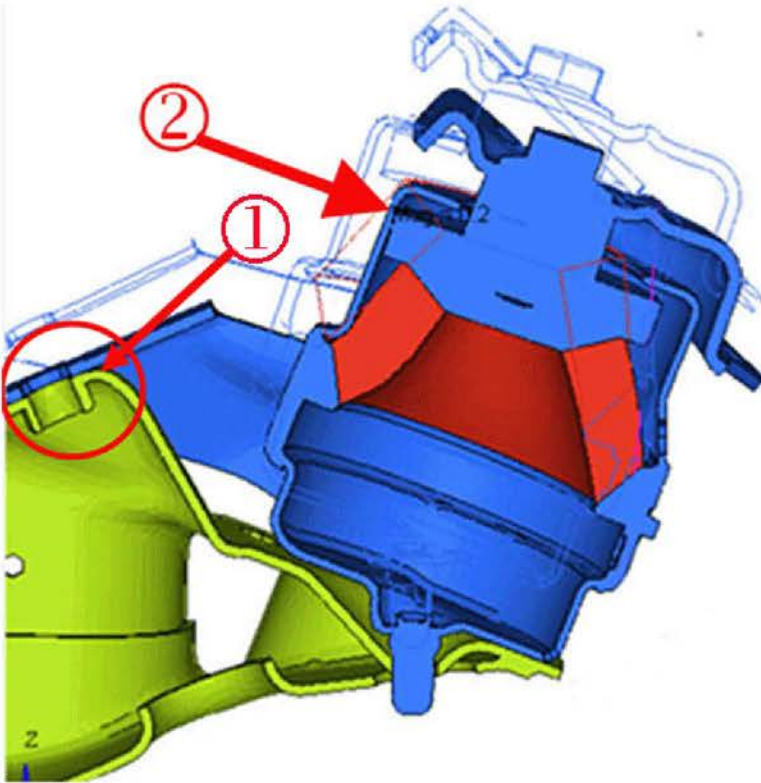
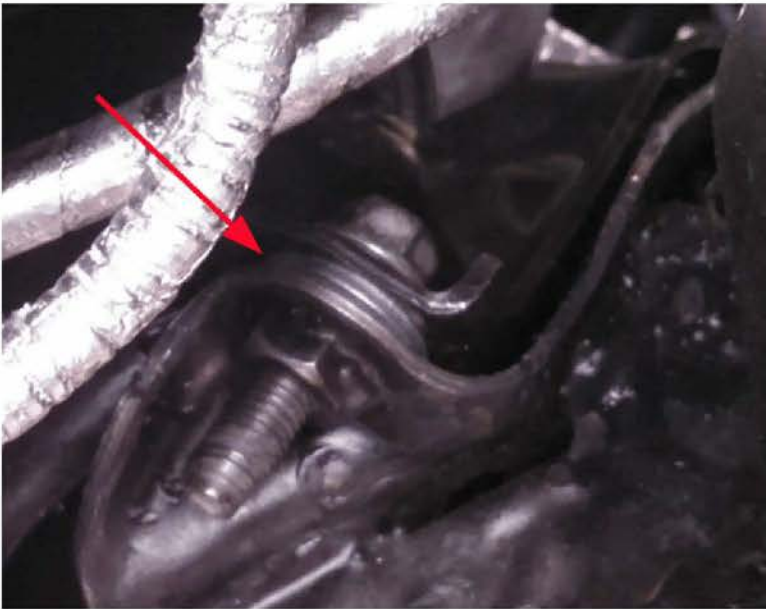
Spacer Washer at Frame Bolt Location Example

Note: Often the idle vibration caused by ground-out within an engine mount (2) may be able to be turned off/on with a single bolt location – shimming that bolt location may greatly reduce the vibration. In some cases, a combination of bolt location shimming may be needed.

Note: For spacer washers mild steel is recommended, no stainless; it may be necessary for some locations to use a small amount of adhesive such as 'dum-dum' to hold spacer in place.

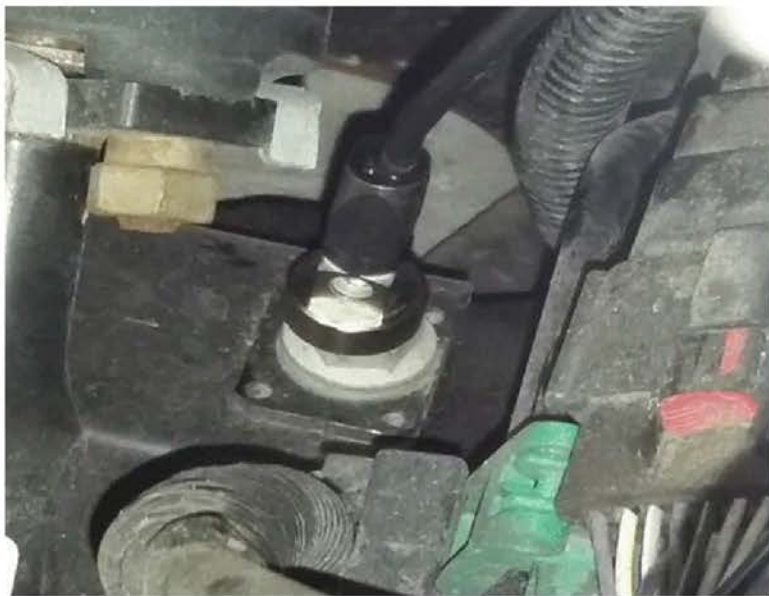
Note: It is difficult to lower amplitude of E1.5 idle vibration at the seat track to about 2.5 mg or lower. Many customers are satisfied with approximately 3 mg or less. Some customers may not be satisfied until the idle vibration is brought below 3 mg, closer to 2.5 mg.

6. While the tri-axis sensor is mounted on the inboard seat track forward most location, Channels A-C – Add a second Pico sensor tri-axis or single plane using Channel D.
7. Place the added Pico sensor on the middle engine mount bolt head, beginning with RH side.
8. For Pico readings from the mount, focus on Vertical E1.5. (suggest removing lateral and fore/aft channels from display, and removing E1 and E4 from display).
9. While the idle vibration is active, record the E1.5 amplitude (mg).
10. Repeat steps 6-9 for LH side while the idle vibration is active, and compare readings.
11. Focusing on the side with highest E1.5 amplitude (mg), perform the following:
