Service Bulletin

Subject: Engine Vibration - Resonance/Boom Between 40 To 60 MPH

Models: 2010 - 2017 Chevrolet Equinox
2010 - 2017 GMC Terrain
Equipped With the 2.4 Cylinder Engine (RPO's LAF and LEA)

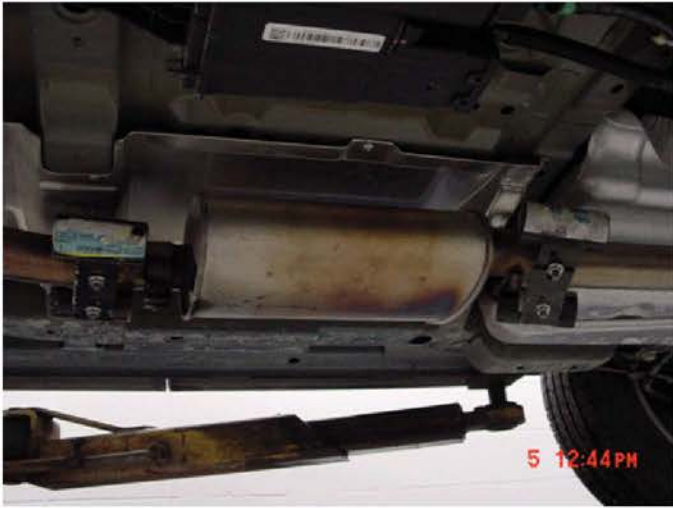
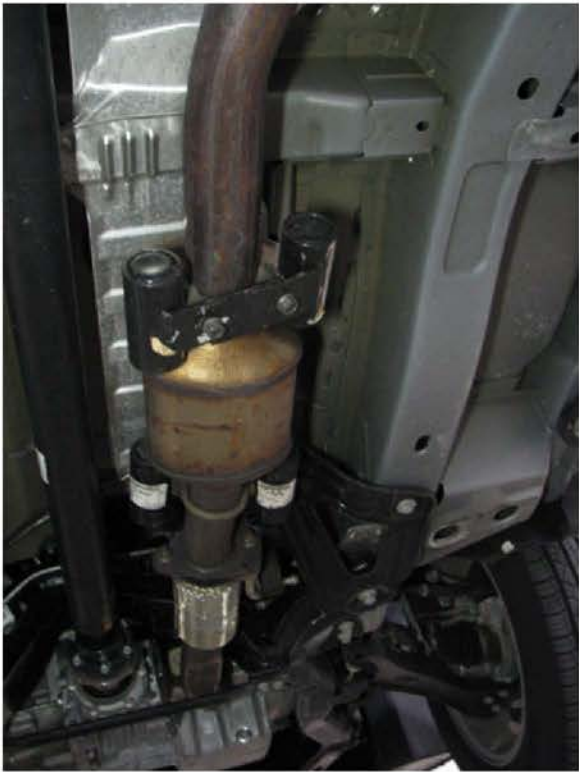
Some customers may comment that a resonance type vibration occurs between 40 to 60 MPH.

In most cases the engine must be under a slight load such as A/C compressor engagement, light throttle, and in 6th gear tcc applied.

It also is described as a 2nd order engine boom or vibration. In most cases this is an inherent condition on 4 cylinder models, however in some cases this condition is much more amplified.

If additional steps are required place two sets of exhaust dampeners (part #10199232 and attach with 2 1/2" exhaust clamps, part #15595206) one set before and one set after the front catalytic converter.

It may be required to move the pair of dampeners along the exhaust system to get the best results (photos attached).

Fabricate 2 dampers using the following procedure:

1. Obtain 4 dampeners, Part Number 10199232.
2. Line up 2 dampeners so the dampener pipes are opposite of each other.
3. Line up one mounting hole from each dampener with the holes of an appropriate size exhaust clamp.
4. With all of the holes lined up, weld the flat portion of the dampeners together and to the flat part of the exhaust clamp
5. Attach the dampeners to the exhaust system using exhaust clamps.
