Service Bulletin

PRELIMINARY INFORMATION

Subject: MIL On With DTC P0016 And/Or P0017 Setting On A Properly Timed Engine Or Crank No Start

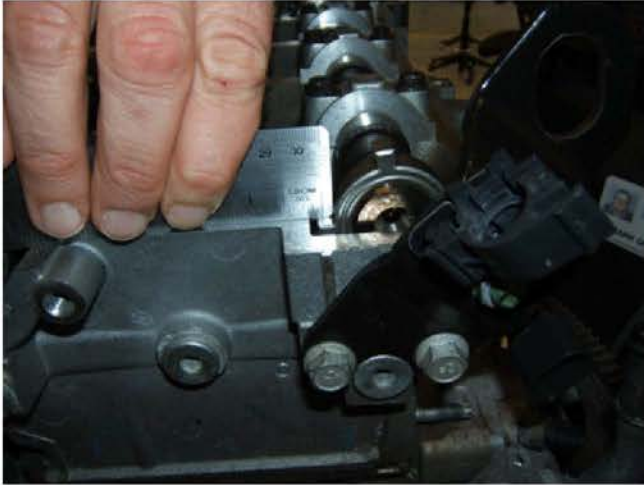
To check the Exhaust Cam reluctor position LE5 ONLY:

This may be the result of a camshaft reluctor that has moved on the camshaft. The reluctor is a press fit and is not indexed/keyed to the camshaft--it is an

interference type fit. An overheat condition may contribute to the concern, causing the reluctor to spin on the camshaft when hot. If the reluctor spins far enough, it can create a crank no start condition.

With the exhaust camshaft positioned so that the valves for #4 cylinder are at maximum lift (fully opened valves), the reluctor should be flush/parallel to the rocker cover gasket surface as shown in the photo below. If the reluctor position does not line up correctly, the exhaust camshaft must be replaced.
