Service Bulletin

Subject: Rattle Noise From Second Row Seat

Models: 2015-2016 Cadillac Escalade Models
2015-2016 Chevrolet Suburban, Tahoe
2015-2016 GMC Yukon Models
Trucks built with 2nd Row Bucket Seats Prior to 01/05/2015
Trucks built with 2nd Row Split-Bench Seats Prior to 09/21/2015

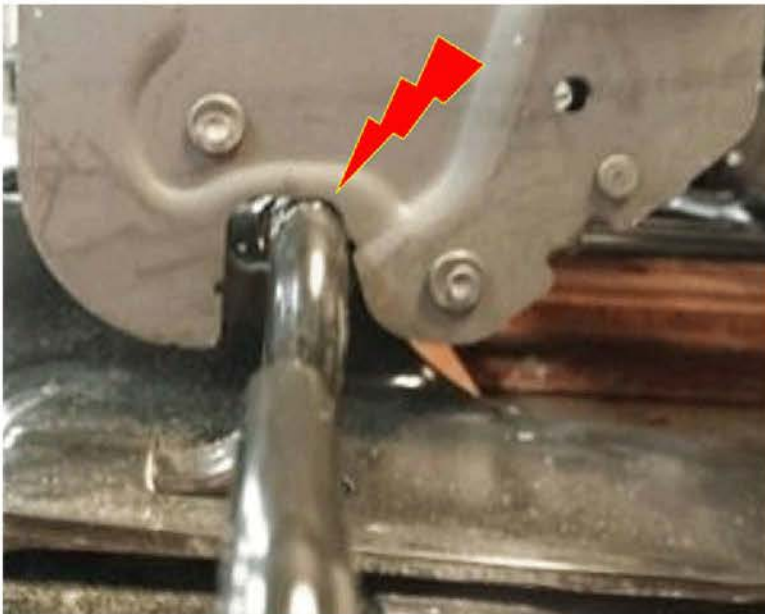
Condition 1: Striker not aligned properly fore/aft in latch opening, see picture below

This could cause a rattle or the striker to drag on the side of the latch opening not allowing the seat to flip forward or latch down easily.

Condition 1 Repair: Striker not aligned properly fore/aft in latch opening

To repair this condition, rework/adjust the striker in the direction to center it in the latch opening. An adjustable wide mouth metal working tool may be used to carefully rework/adjust the striker just enough to center in the latch opening, as shown below.

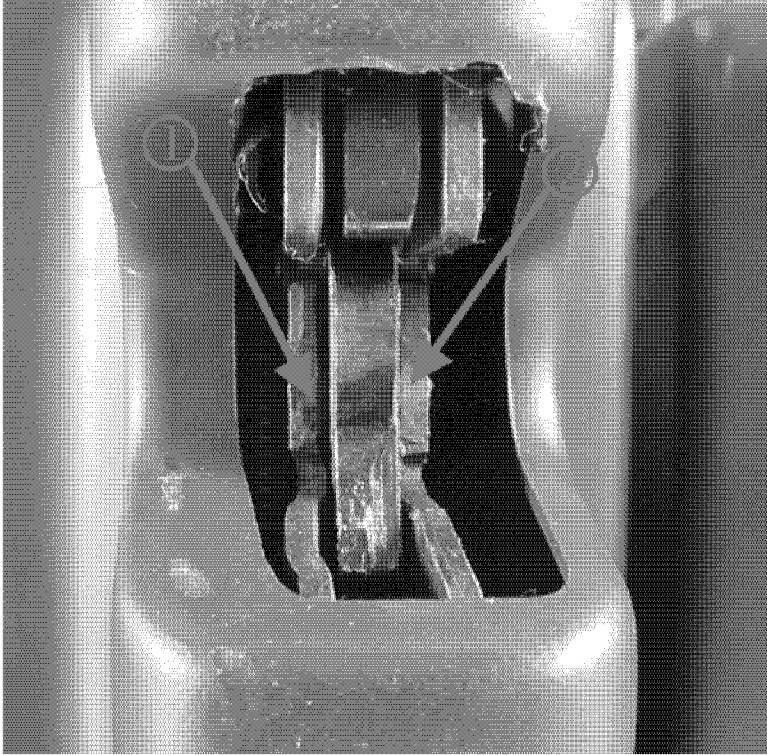
Condition 2: A seat bottom latch (inboard and/or outboard) may have an unequal latch opening side-to-side for the striker to seat into, see picture below.

Opening (1) may protrude down farther than opening (2), which can cause a rattle, and which may make it difficult to secure and/or release latches.

With the seat latched down, if the striker to latch interface is inspected on both sides of a latch, there will be a gap on one side of the latch and no gap on the other side of the same latch.

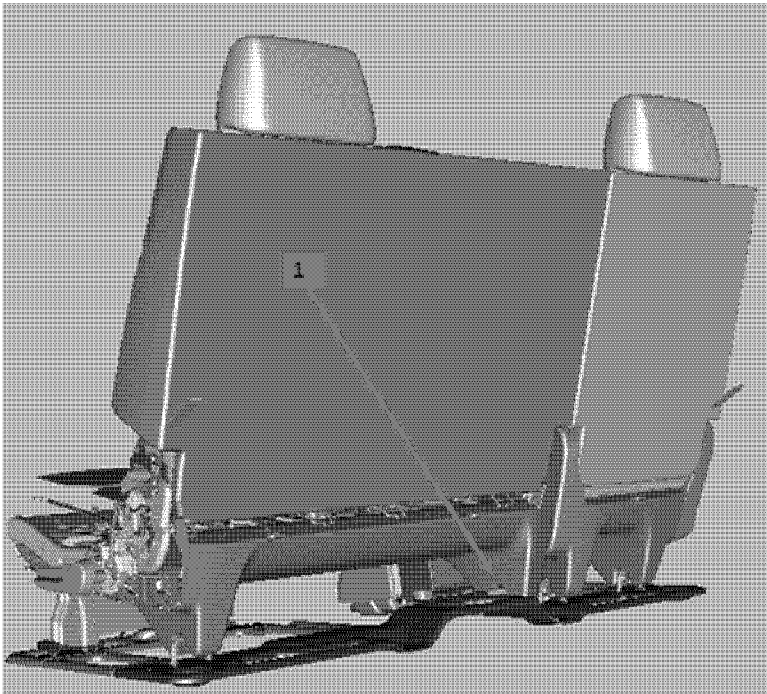
Condition 3: 60/40 Split Bench Seat (vehicles built prior to 09/21/2015): 60-percent long side bench, inboard latch (1) may not be properly aligned fore/aft in striker opening.

Could cause a rattle and/or the striker to drag on the side of the latch opening not allowing the seat to flip forward or latch down easily.

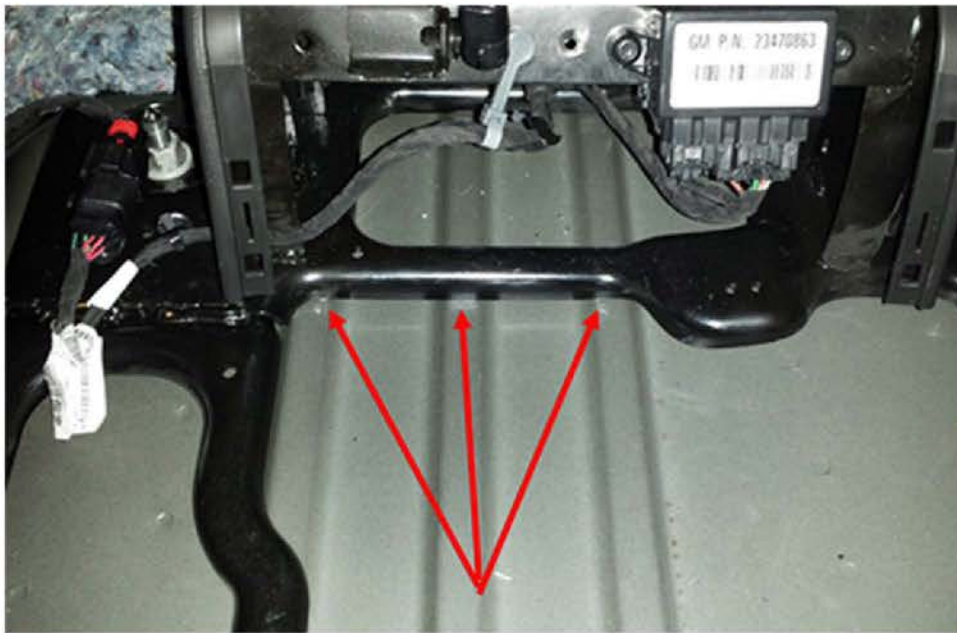
Condition 4: Seat base plate contacting/rattling against ribs of floor pan.

Condition 4 Repair: Seat base plate contacting/rattling against ribs of floor pan

4.3 Apply Mylar tape to the floor pan to provide relief for the rattle condition, then reevaluate.

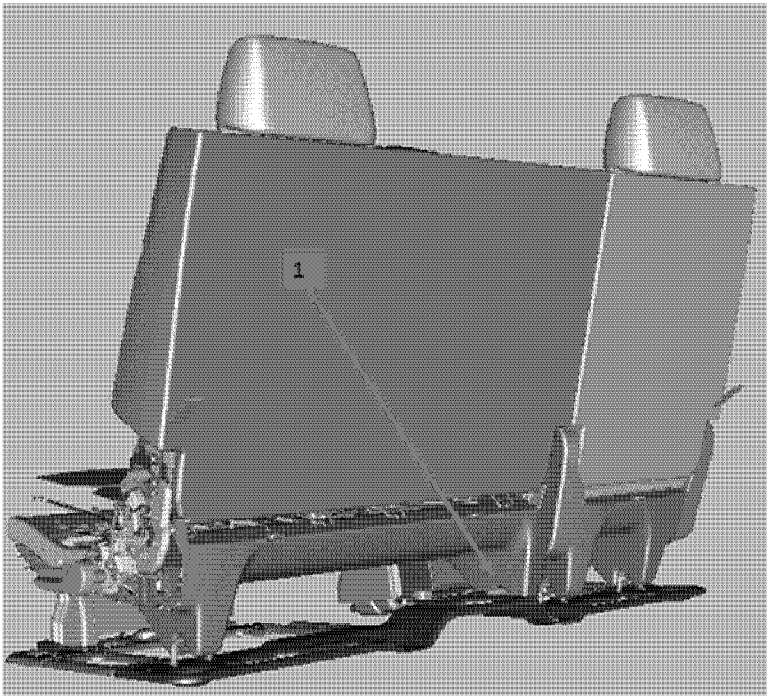
Condition 3 Repair: 60/40 Split Bench Seat (vehicles built prior to 09/21/2015): 60-percent seat, inboard latch (1) may not be properly aligned fore/aft in striker opening.

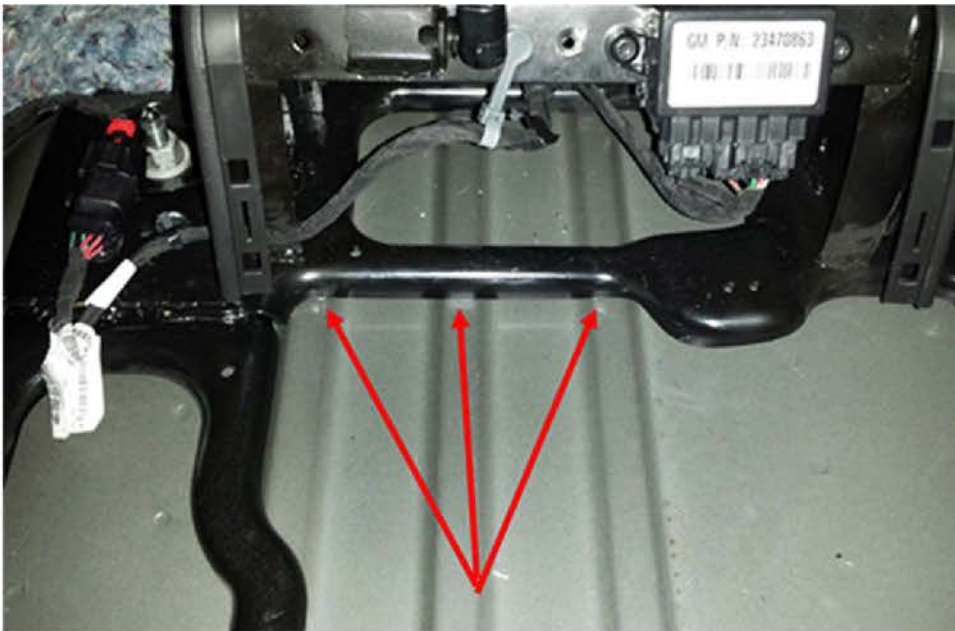
4.2 Inspect the seat base plate for contacting the ribs of the floor pan, as shown below. If contact is present paint damage may be visible at the area of contact.
