SERVICE BULLETIN

APPLICABILITY: 2014MY XV Crosstrek Hybrid Models (HEV)
SUBJECT: Relay Freezing Causing DTCs P1C30 and U0110

NUMBER: 07-98-15
DATE: 01/22/16

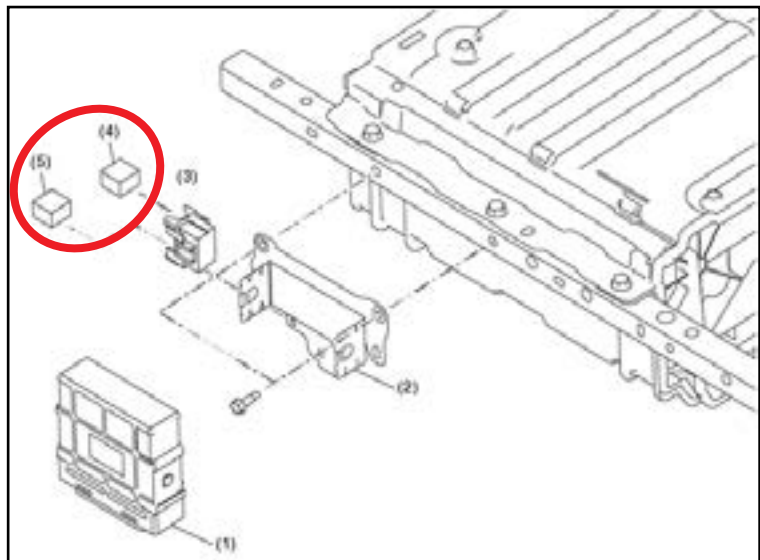
This bulletin announces a change to the power supply relay used for the Drive Motor Control Module (DMCM) and the cooling fan / drive motor inverter. In specific cold climate (below freezing) conditions, if there is a small amount of condensation inside the relay, it can in rare cases freeze and cause the relay to remain open which in some cases, sets DTCs P1C30 and / or U0110.

1. Drive Motor Control Module (DMCM)
2. DMCM Mounting Bracket
3. Relay Holder
4. DMCM Power Relay
5. Cooling Fan / Drive Motor Inverter Power Supply Relay

The part number for the new relay is **25230AA190**.

- If DTC P1C30 and / or U0110 are found stored in memory and the outside temperatures are (or were recently) below freezing, replace both of the power supply relays (4 and 5) as shown in the illustration above.
- Record the customer's radio station presets (and navigation favorites where applicable).
- When either of the power supply relays is replaced, both the auxiliary and the engine start batteries must be disconnected, **auxiliary battery first**. Remove the 12mm nut from the restart battery sensor stud and remove the cable along with the ground terminal from the Auxilliary battery.

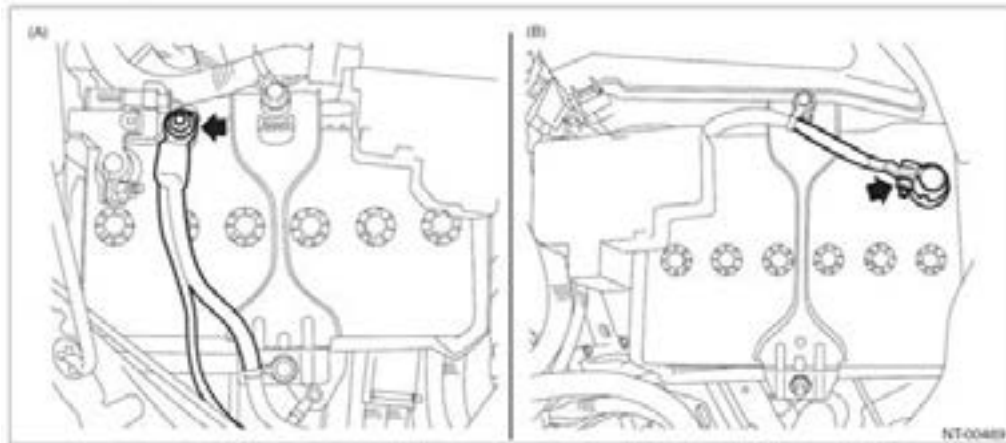
12v Engine Restart Battery (A)

12v Auxiliary Battery (B)

IMPORTANT: DO NOT remove the sensor assembly from the restart battery terminal.
