GROUP	NUMBER	
		CAMPAIGN	16-01-016	
		DATE	MODEL(S)	
		APRIL 2016	GENESIS SEDAN (BH) EQUUS (VI)	
SUBJECT:	WINDSHIELD WIPER MOTOR COVER REPLACEMENT			
	(RECALL CAMPAIGN 140)

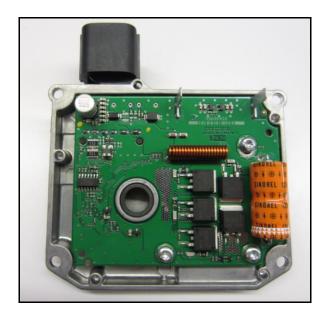
**Description:** The subject vehicles are equipped with a windshield wiper motor which may have been manufactured with a cover seal that could degrade over time, eventually causing corrosion on the wiper motor's printed circuit board. If the corrosion progresses, the windshield wiper motor could either function intermittently or stop functioning. If the windshield wipers become inoperative during inclement weather, driver visibility could be reduced, increasing the risk of a crash.
