IB16-J-001

CRANK NO START – INSPECT FOR SHEARED CAM PIN

- 2012-2017MY Isuzu N-Series
Equipped with 6.0L Gas V-8 Engines

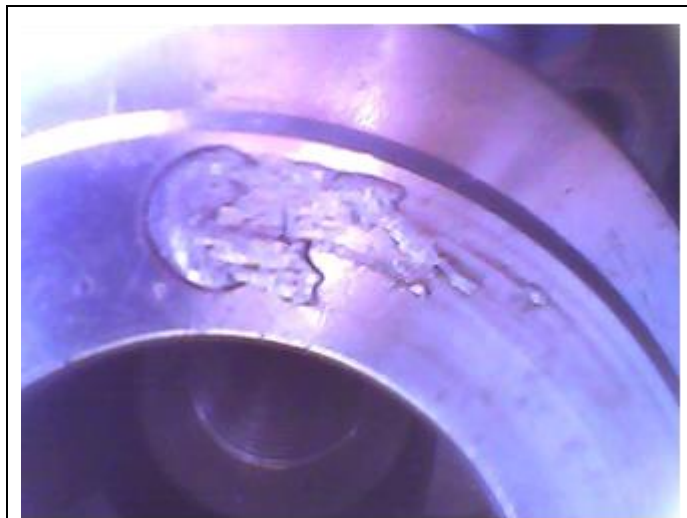
This concern may be the result of a sheared camshaft sprocket locating pin due to the camshaft seizing to the camshaft bearings at one time.

4. If you have completed steps 1, 2, or 3, remove the front cover to inspect for a sheared cam sprocket locator pin. See sheared cam locator pin in Figure 1 below.

5. If it is determined the cam sprocket locator pin has sheared the engine assembly will need to be replaced. Technicians are to contact the IQC per bulletin IB09-X-001E. Follow the instructions provided from the IQC to complete the repair.
