# Service Bulletin

Bulletin No.: 16-NA-060

**Subject:** Difficulty Shifting Out of Park or into Park

Brand:	Model:	Model Year:		VIN:		Engine:	Transmission:
		from	to	from	to		
Chevrolet	Malibu (VIN Z)	2016	2016				
	Volt	2016	2017

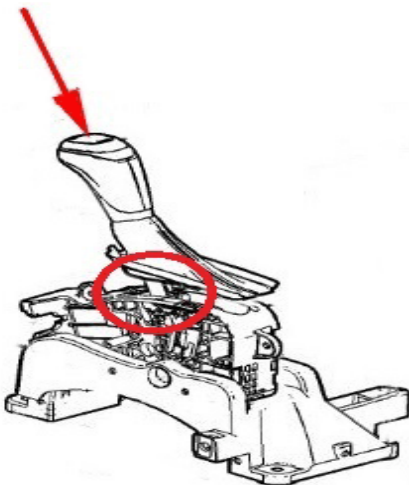
4421604

<b>Involved Region or Country</b>	NORTH AMERICA (All), ISRAEL (Malibu), KOREA (Volt)
<b>Condition</b>	Some customers may comment that it is difficult to move the shifter out of Park or into Park.

Do not immediately replace any parts until the transmission control lever knob assembly has been validated to be fully installed onto the shifter and operating correctly.

While pressing downwards on the knob firmly with both hands, validate any movement felt and the bottoming out of the knob to shifter.
