Service Bulletin

File in Section: -
 Bulletin No.: 16-NA-045
 Date: May, 2016

Subject: Bent Rear Shock Locator Pin(s) Noticed During Rear Shock Absorber Replacement

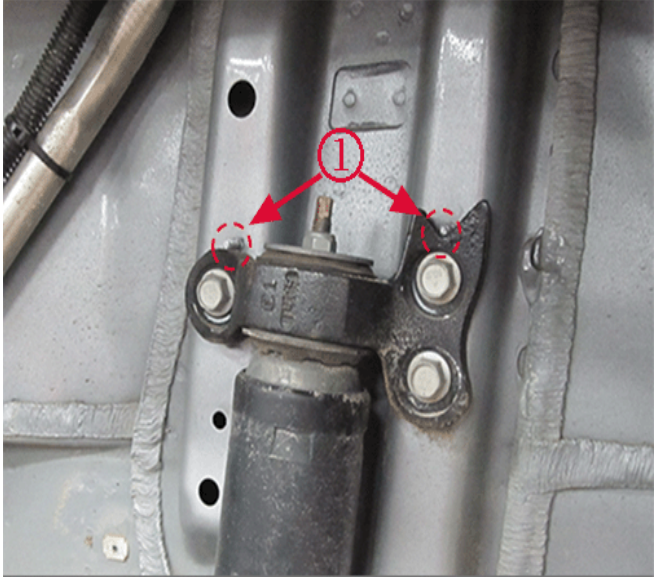
Cause	<p style="text-align: right; font-size: small;">4409789</p> <p>When replacing a rear shock absorber, upon removal of the shock, a technician may comment on finding a bent locator pin (1) on the rear wheel well/shock mount area.</p> <p>One, or both, of the rear shock locator pins may bend in cases where the vehicle is harshly driven over rough terrain.</p>

The rear shock locator pins are strictly an aide in positioning the shock during vehicle assembly, and **DO NOT** perform a function for retaining the shock. Any bent locator pin(s) should be cut off **prior** to installation of the new shock and a corrosion protection applied, following the Service Procedure below.
