# Service Bulletin

Bulletin No.: 16-NA-148

**Subject: Power Trunk Does Not Open When Activating the Key Fob or Touch-pad**

Brand:	Model:	Model Year:		VIN:		Engine:	Transmission:
		from	to	from	to		
Chevrolet	Malibu (VIN Z)	2016	2016			All	All

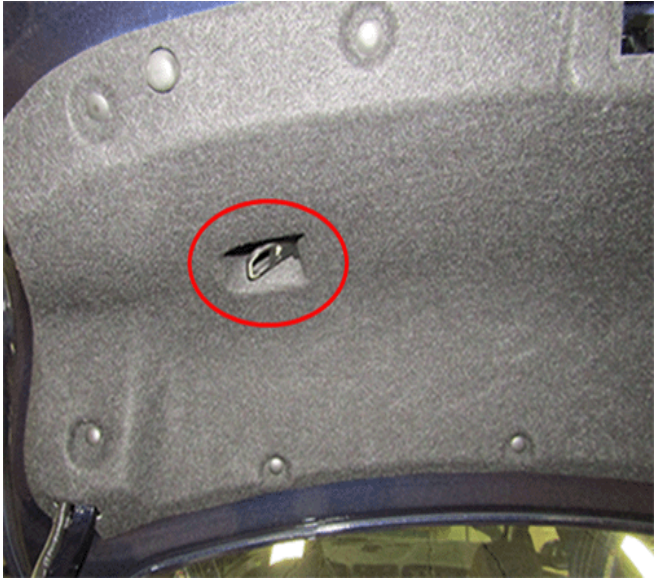
<p style="text-align: right; font-size: small;">4504495</p> <p>Whether positioned incorrectly at the opening in the trunk lid trim panel, or due to being pulled/pushed by items in the trunk, there may be interference between the ETR handle and the trim material.</p>

Interference from the trim can cause the handle and cable to bind. Any sort of preload on the ETR cable will not allow the latch to release when any of the electric switches are used.

If this condition is present, it will be necessary to enter the trunk through the rear seat access and pull the ETR handle. Refer to *Opening the Rear Compartment Without Electrical Power* in SI.

Once access is gained, move ahead to the Service Procedure below to correct the ETR handle/trim panel interference.
