## Field campaign

<b>Topic</b>	Mulsanne engine and transmission control module software update (SC15/01)
<b>Market area</b>	Bentley: worldwide (2WBE)
<b>Brand</b>	Bentley
<b>Transaction No.</b>	2038952/2
<b>Campaign number</b>	EA22
<b>Note</b>	
<b>Type</b>	
<b>US code</b>

## Repair instructions

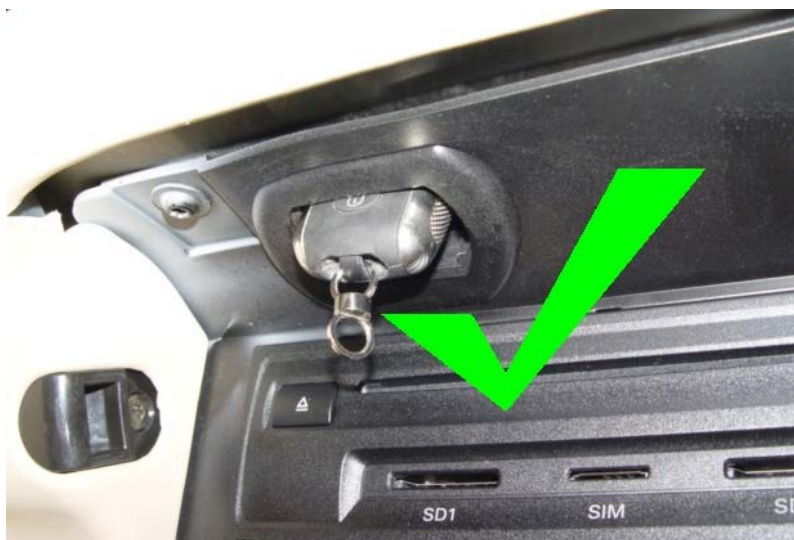
Figure 1

**IMPORTANT:** It is imperative that any adjoining keys are removed from the ignition key ring and the single ignition key is used only (see Figure 1) as extra weight may cause the key to withdraw from the reader

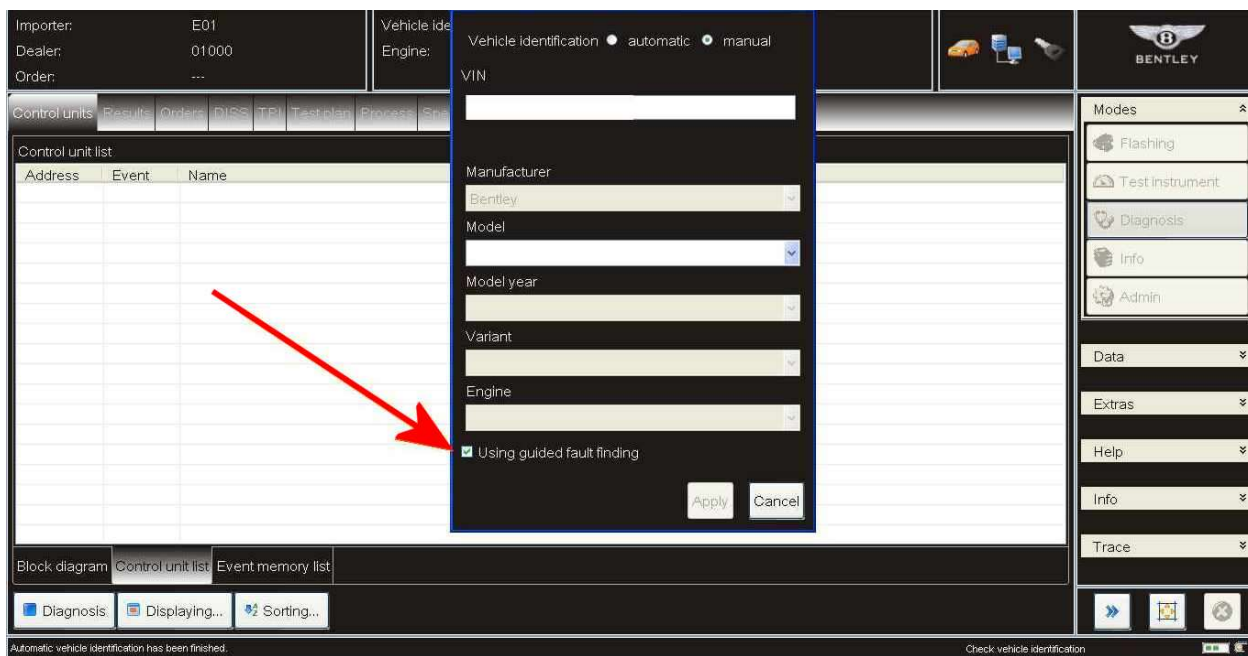
Figure 2

- Ensure the Using guided fault finding box is ticked (Figure 2) - follow all on screen prompts to allow the guided fault finding control module sweep to complete

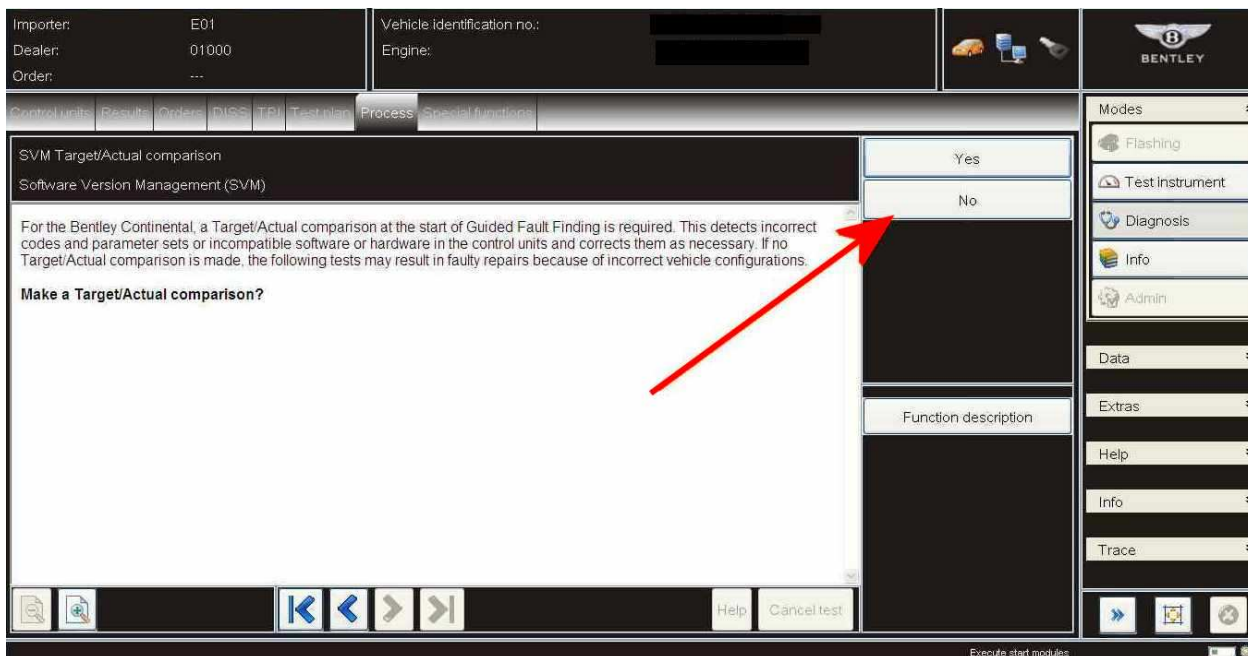
Figure 3

**IMPORTANT:** When requested to Make an SVM Target/ Actual comparison please select No (Figure 3)

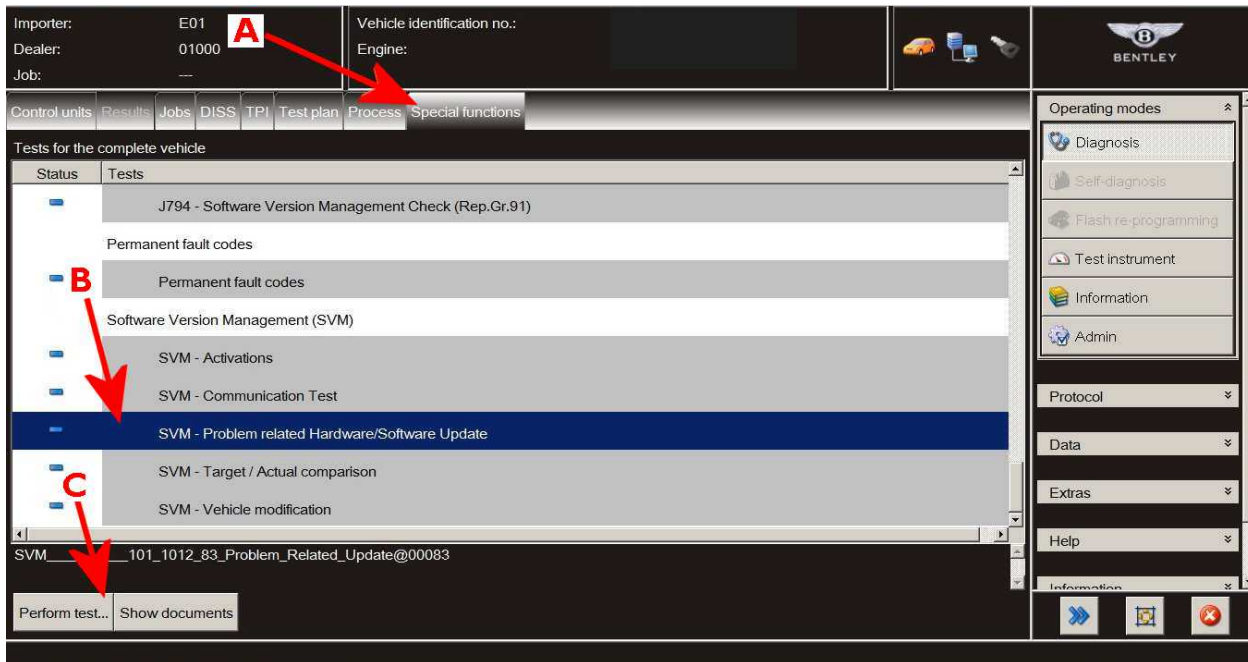
7. - Once the control module sweep within Guided Fault Finding is complete, Select – Special functions as shown in Figure 4 (point A)

- Select SVM - Problem related Hardware/Software Update (point B)

- Select Perform test (point C) and follow all on screen prompts

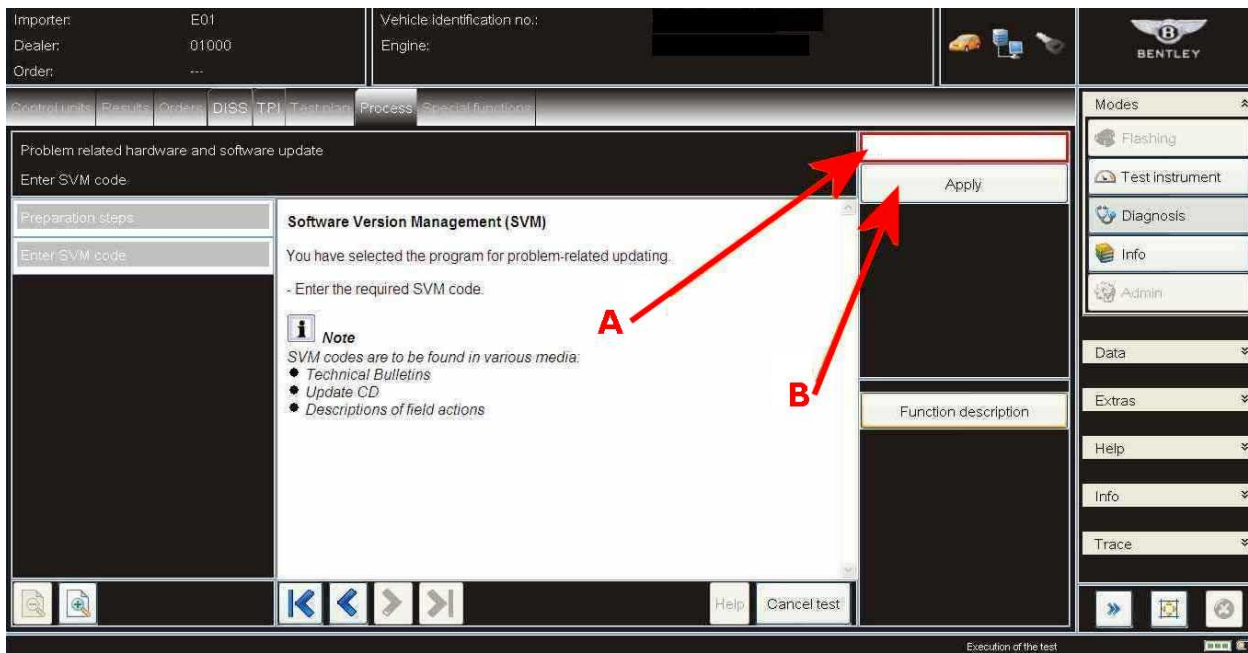
Figure 5

- Once at Figure 5, please insert the SVM code 3Y013MYEMS01 (point A) and select Adopt (point B) and follow all on screen prompts

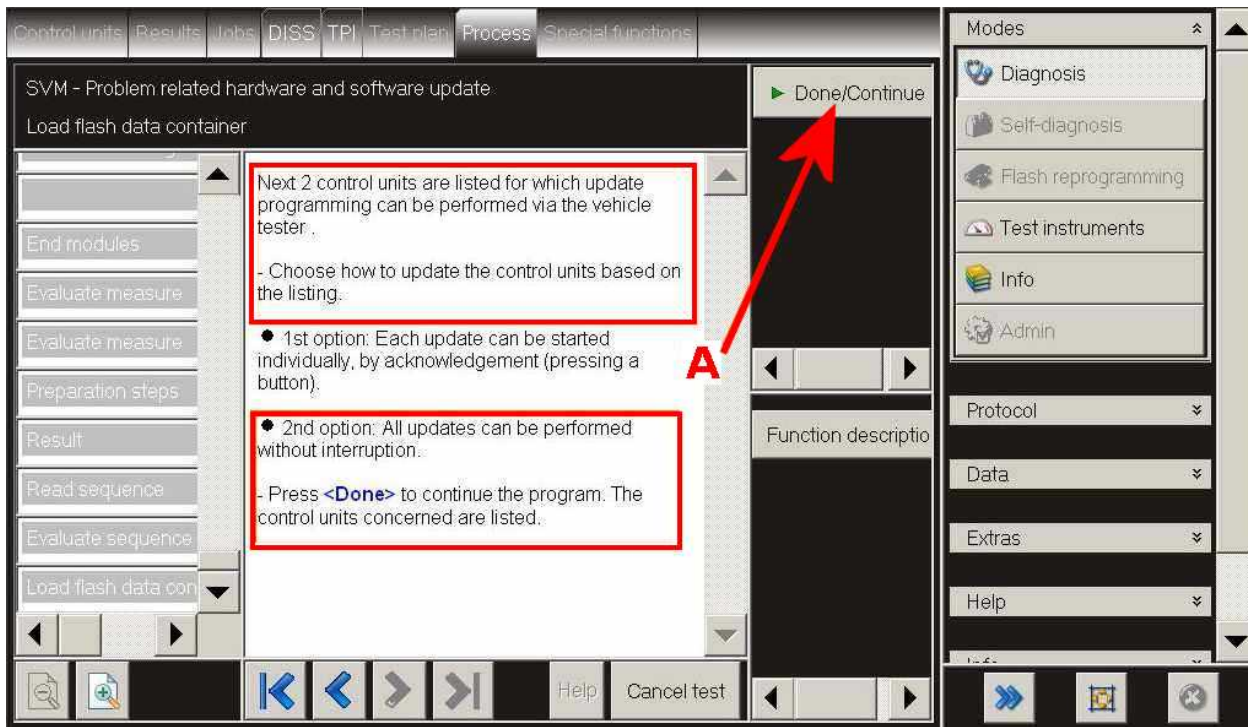
Figure 6

8. Please read all text within the highlighted boxes shown in Figure 6, as during the next steps you will be asked to select how the updates should be performed, It is recommended to perform all updates without interruption (2<sup>nd</sup> option)

- Select Done/Continue – (Point A) and follow all on screen prompts to update the engine and transmission control units

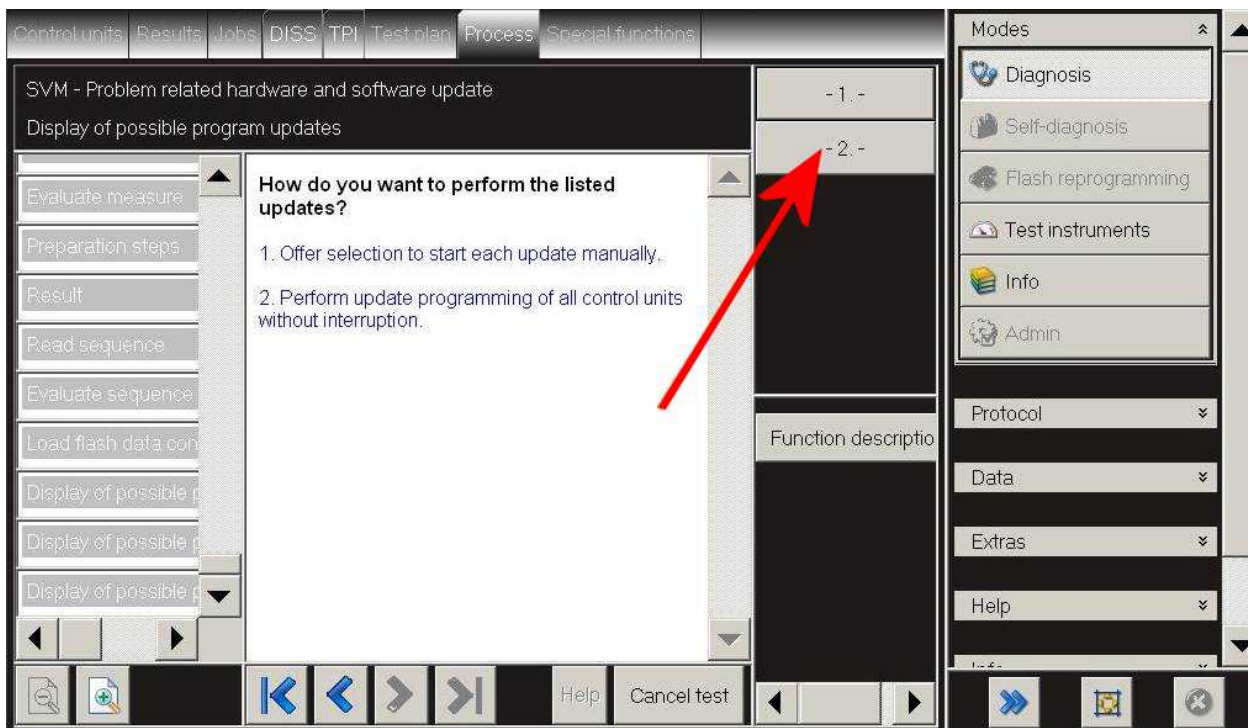
Figure 7

9. Once at Figure 7, select – 2. Perform update programming of all control units without interruption, and follow all on screen prompts until the Engine control module and Automatic transmission control module was successful

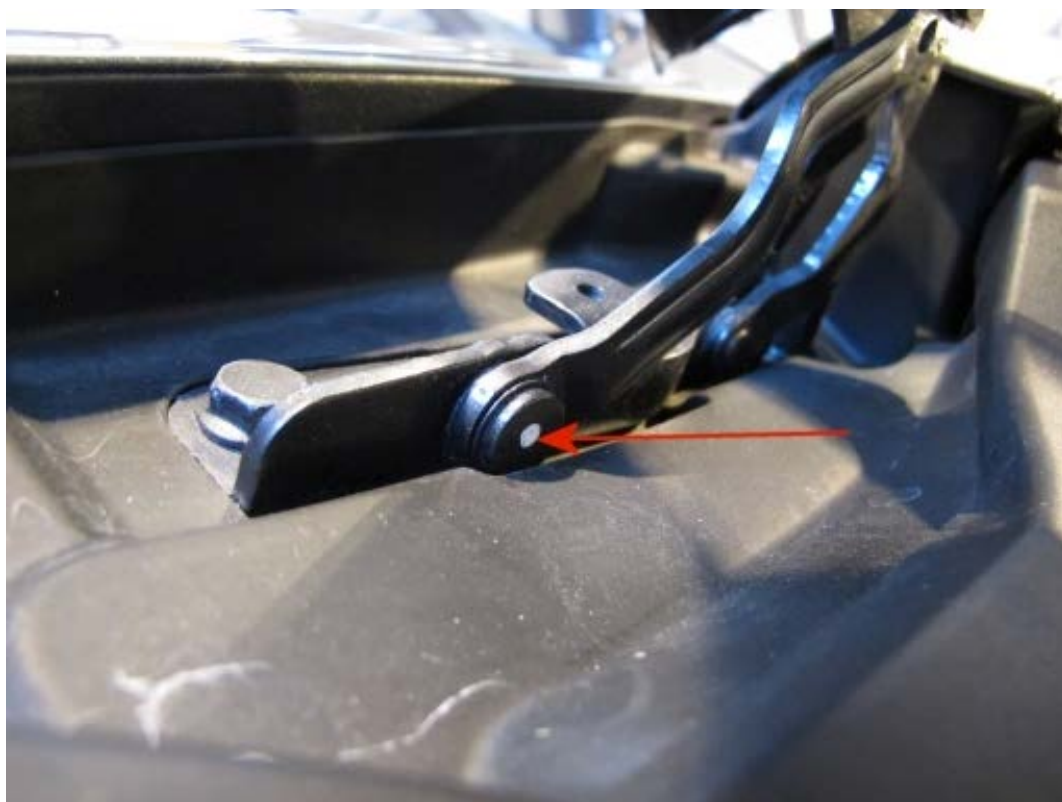
Figure 8

- Once complete, place a white paint completion mark on the right hand bonnet hinge (see Figure 8).

White paint completion mark on the right hand bonnet hinge (see Figure 8).
