Field campaign

Topic	Software update ABS (SC16/04)
Market area	Bentley: worldwide (2WBE),Hongkong-Macau (5HK)
Brand	Bentley
Transaction No.	2043640/7
Campaign number	EA42
Note	
Type	Pre-delivery & workshop service campaign
US code

Bentayga

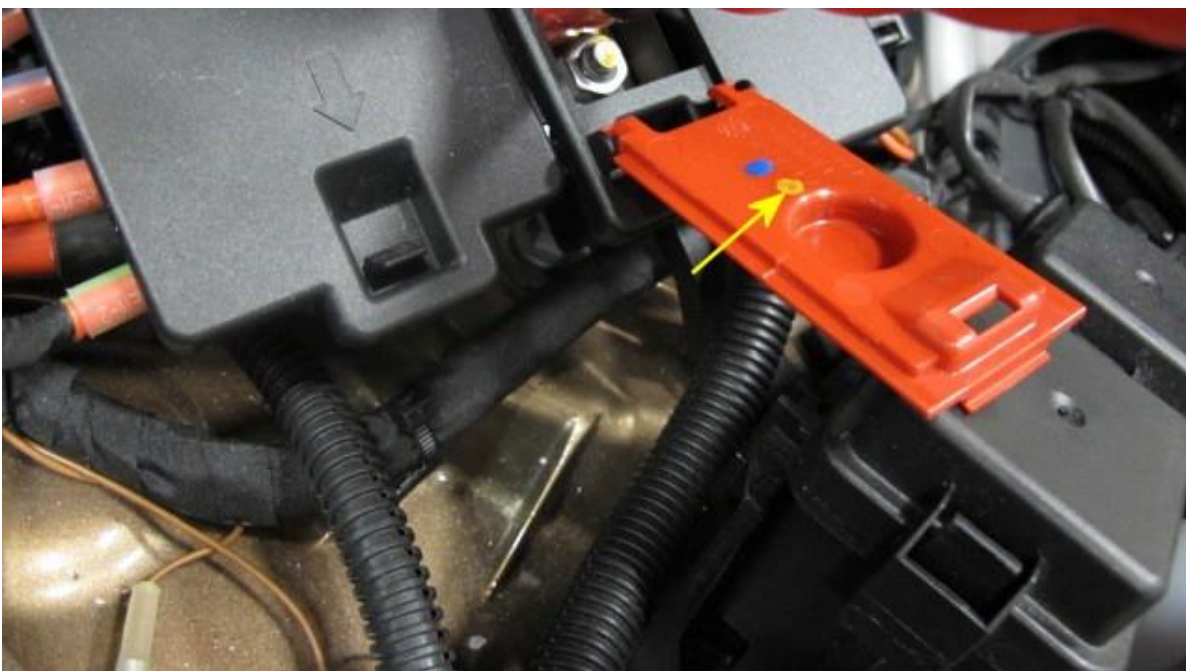
Figure 8

If the vehicle is not already listed as repaired in the "Repair history" (ElsaPro), check for the campaign identification mark, yellow spot to the under bonnet battery charging post adjacent to the right hand bonnet hinge (see Figure 8), should neither be evident carry out the required work in accordance with these instructions

On completion apply a yellow campaign completion mark to the under bonnet battery charging post adjacent to the right hand bonnet hinge (see Figure 8)
