GROUP		NUMBER	
Q	SO HYUI		TIES. CA	MPAIGN	16-01-036	
Technical Service Bulletin		DATE		MODEL(S)		
	recinical		AUG	UST 2016	ELANTRA (ADa)	
SUE	BJECT: OU	OUTSIDE DOOR HANDLE FASTENER TORQUE ADJUSTMENT (SERVICE CAMPAIGN TNN)				
		-				
* IMPORTANT		*** Dealer Stock and	*** Dealer Stock and Retail Vehicles ***

SUBJECT: OUTSIDE DOOR HANDLE FASTENER TORQUE ADJUSTMENT (SERVICE CAMPAIGN TNN)

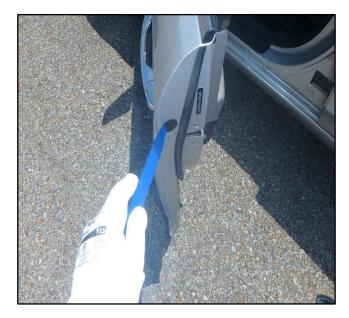
1. Open the driver door and remove the black cover to access the door handle base screw using a trim tool.

Use No-Mar trim tool to prevent damage to paint.

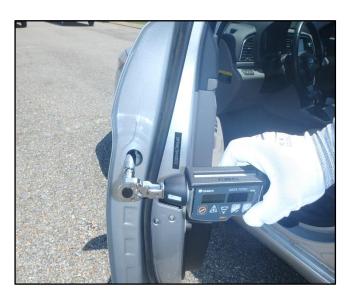
Description: Certain 2017 Elantra (ADa) may have lower than specified torque on the fastener securing the outside door handle(s). This may lead to improper operation of the outside door handle(s).

2. Use torque tool to check the torque and tighten screw as necessary.

Tightening torque: 7.8Nm – 10.8Nm (0.8 ~ 1.1 kgf.m, 5.8 ~ 7.9 lb-ft)

Set wrench to within spec limit **8.9 Nm** (**0.9kgf.m, 6.6 lb-ft**) recommended. Tighten screw as needed. In some instances, tightening may not be required.

Do not overtighten screw. This can damage outside handle cap and may require replacement. This will not be covered under warranty.
