# Replace Key Batteries and Update Key Firmware

**Classification** Campaign Bulletin **Section/Group** 17 - Electrical **Country/Region** United States

**Year** 2016 **Model** Model X **Version** All

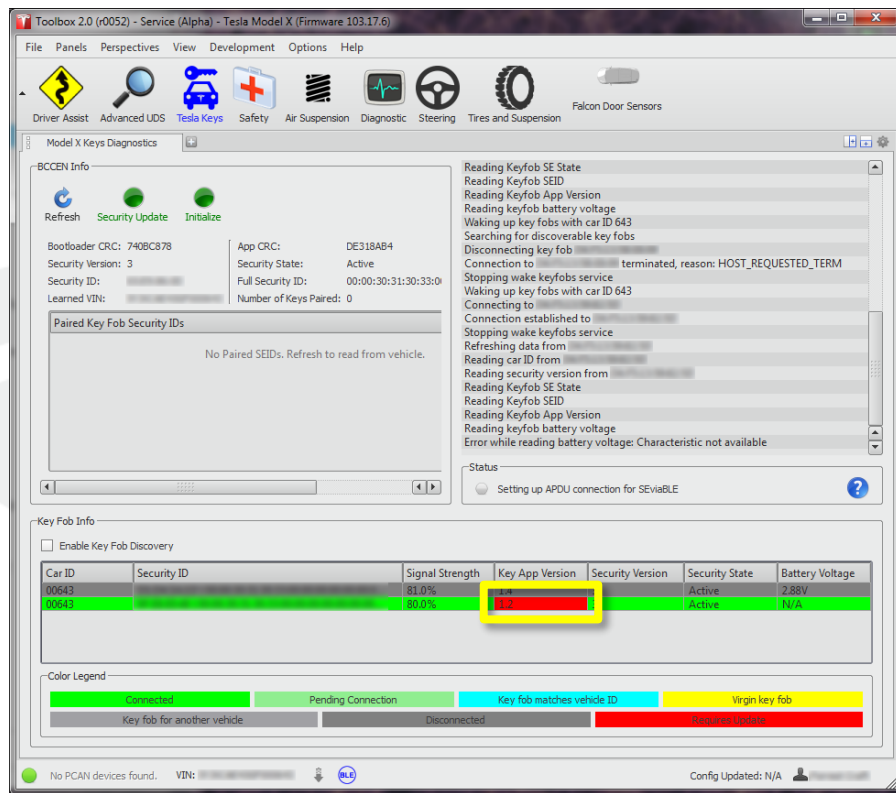
Figure 6

- If the color is green, skip to step 17.
- If the color is red (Figure 6), continue to the next step.

13. Right click the key and select **Update Key App**.

14. Right click the key and select **Verify Provisioning**.
