## Wind Noise From Front Doors And Windows

| <b>Classification</b> | Campaign Bulletin | <b>Section/Group</b> | 45 - Noise, Vibration & Harshness | <b>Country/Region</b> | All |
| <b>Year</b> | 2016 | <b>Model</b> | Model X | <b>Version</b> | All |

This Service Bulletin supersedes SB-16-45-001, dated 3-Jun-16. Each content change is marked by a vertical line in the left margin. Discard the previous version and replace it with this one.

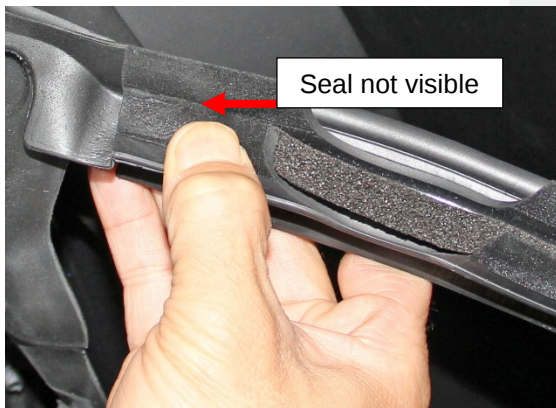
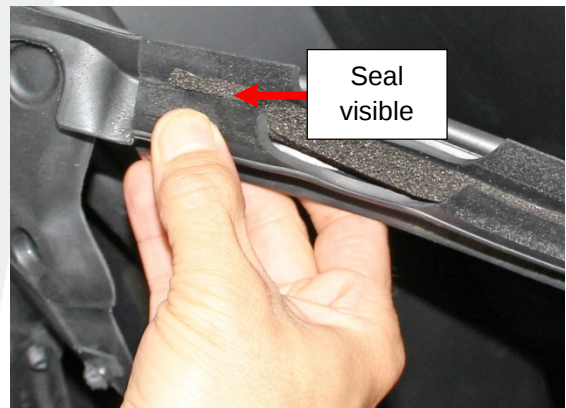
**NOTE:** Ensure that the seal is as low as possible in the channel. When pressing in on the outboard side of the groove, the seal should not be visible (Figures 23 and 24).
