# Resecure Rear Door Wiring Harness

**Classification** Campaign Bulletin   **Section/Group** 17 - Electrical   **Country/Region** United States

**Year** 2016   **Model** Model X   **Version** All

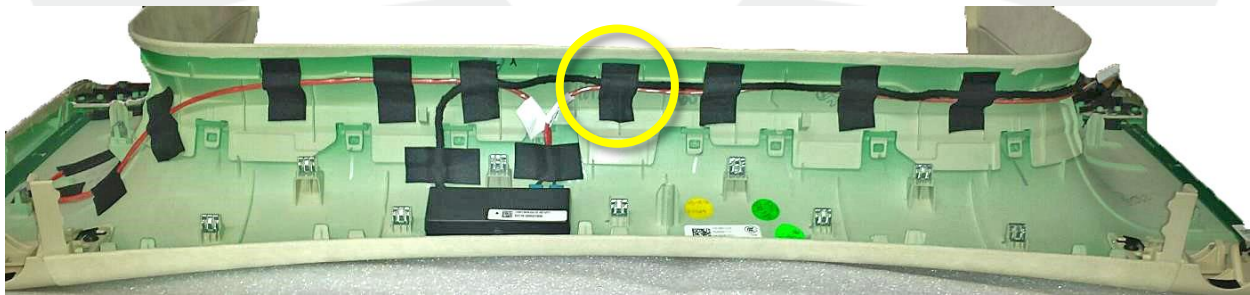
✓ Figure 1 (Harnesses bundled and secured with black polyester electrical tape)

- If the wiring harnesses are bundled together and secured with black polyester electrical tape (Figure 1), continue to step 3.
- If the wiring harnesses are separated (Figure 2) or are secured with duct tape or white textile tape (Figures 3 and 4), skip to step 4.

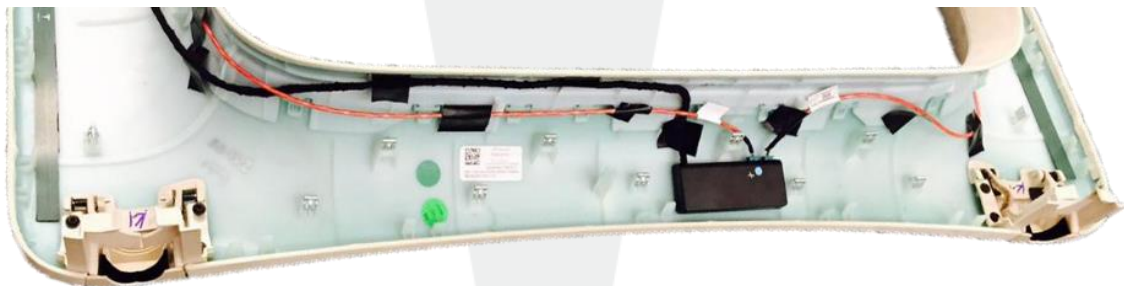
✗ Figure 2 (Harnesses separated)

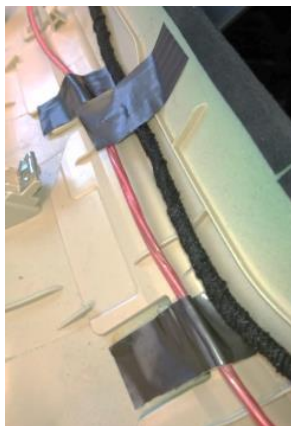
✗ Figure 3 (Harnesses secured with duct tape)

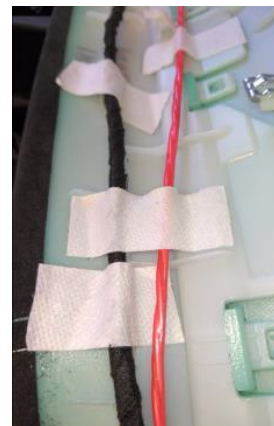
✗ Figure 4 (Harnesses secure with textile tape)

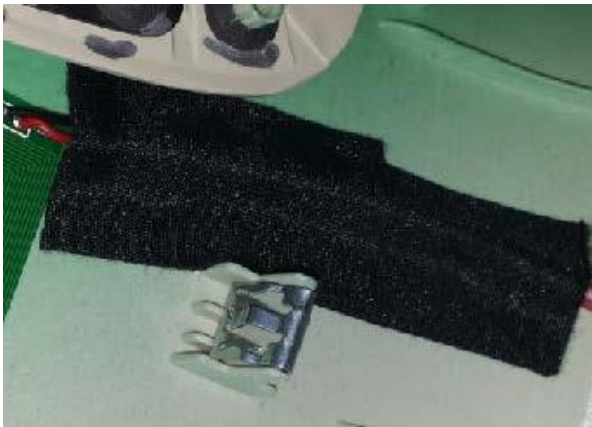
✓ Figure 5

- If the harnesses are secured with black polyester electrical tape (Figure 5), reinstall the LH and RH upper door trim panels and discontinue this procedure.
- If the harnesses are not secured with black polyester electrical tape (Figure 6), continue this procedure.

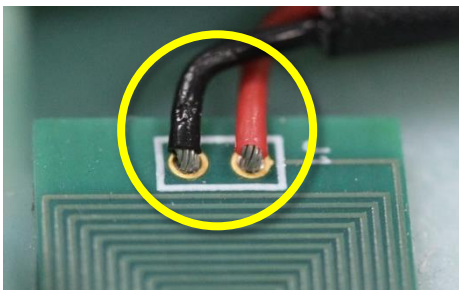
✓ Figure 8

- If the wiring harness is attached to the printed circuit board with a small amount of solder and no exposed wires (Figure 8), continue this procedure.
- If the wiring harness is attached to the printed circuit board with excessive amounts of solder (Figure 9), discard and replace the rear door upper trim panel (refer to Service Manual procedure 15132302), and skip to step 5.
