**DATE:** 8-2-16

**APPLIES TO:** This service bulletin applies to 2015 and 2016 model year, K2, K3, and MM model motorhome chassis built between October 2, 2013 and October 12, 2015 by Spartan Motors USA, Inc.

**CONDITION:** Rear suspension cross member may be missing fasteners.

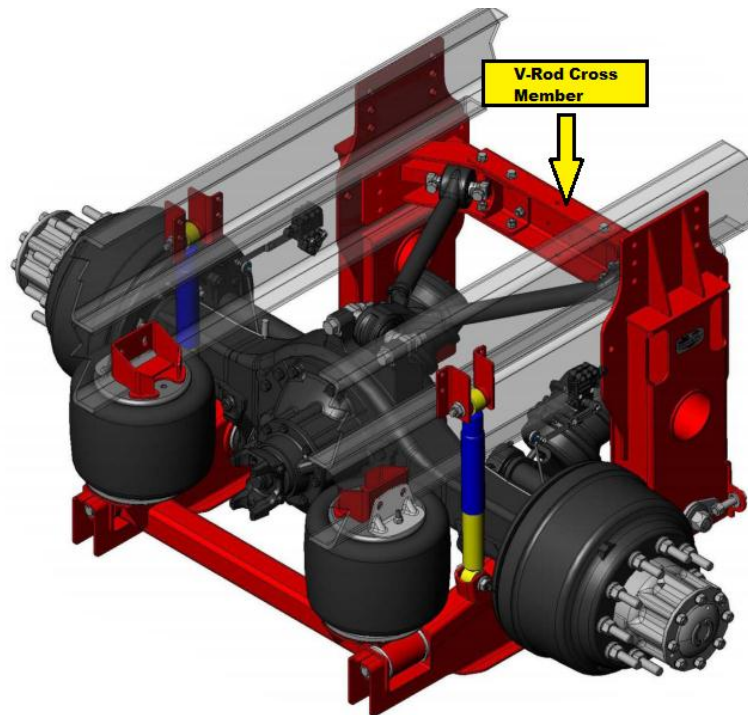
**FIG. 2-1**

1. Gain access to the V-Rod cross member shown in FIG. 2-1.
