Service Bulletin

Bulletin No.: 16-NA-156

Subject: Information on Replacement HMI Modules for Vehicles Built Without Apple CarPlay and Android Auto

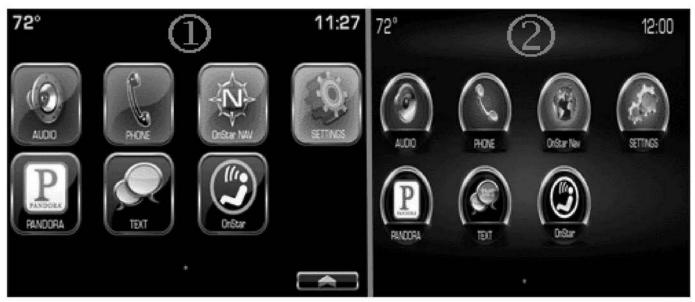
4516716

- 3. The main menu screen of the radio will not have the "projection" icon.
- The Service Parts Identification (SPID) label in the glove box will contain the RPO code "CPO" in addition to the RPO code IO5.
- The RPO list in Warranty History (IVH) will also show "CPO" since it is part of the as built RPO string.
