Service Bulletin

Bulletin No.: 16-NA-159

Subject: Squeak and/or Rubbing Noise from Steering Column Area

Brand:	Model:	Model Year:		Breakpoint:	Engine:	Transmission:
		from	to			
Chevrolet	Colorado	2015	2016	Vehicles Built Prior to April 25, 2016		
GMC	Canyon	2015	2016

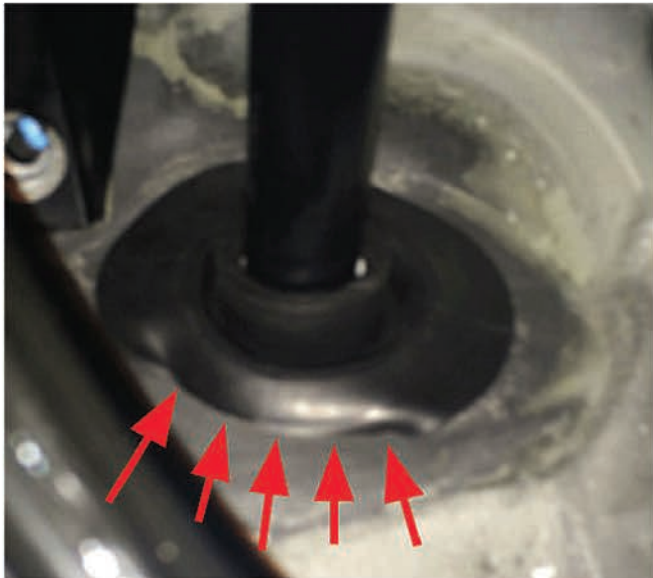
4512167

Involved Region or Country	North America
Condition	Some customers may comment on a squeak and/or rubbing noise coming from the steering column area.
Cause	This condition may be due to the inner and/or outer intermediate steering shaft boots (seals) being out of position.

Inspect the intermediate steering shaft inner and outer boots (seal) for being out of position as shown above. If the boots are out of position, use a flat trim stick to properly seat the boots.
