Service Bulletin

Bulletin No.: 16-NA-170

Subject: Brake Pulsation and/or Vibration During Brake Apply

Brand:	Model:	Model Year:		VIN:		Engine:	Transmission:
		from	to	from	to		
Chevrolet	Corvette	2014	2016

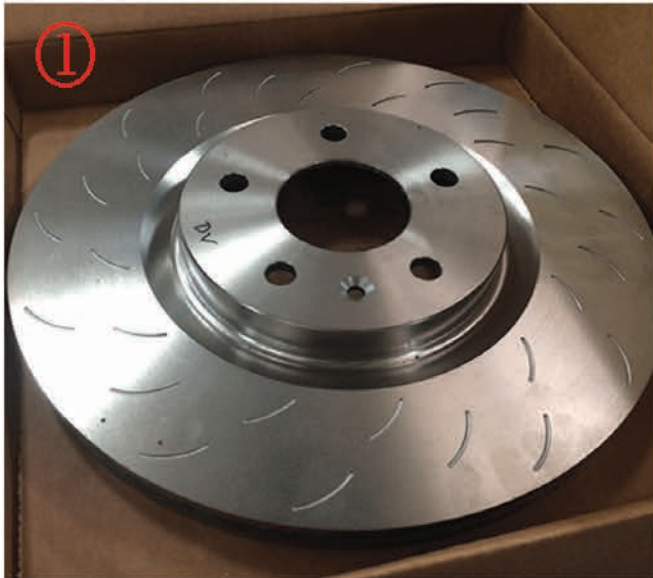
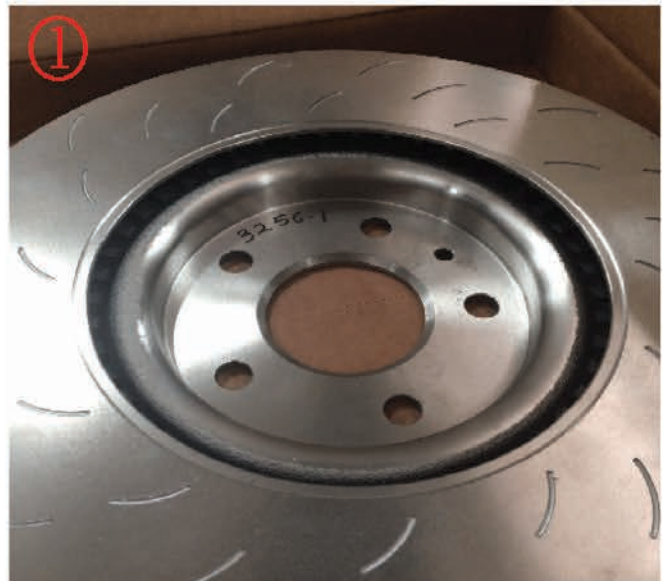
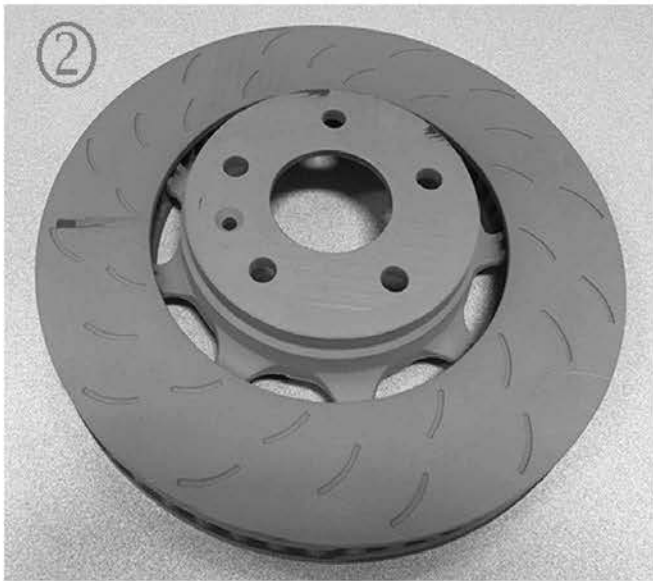
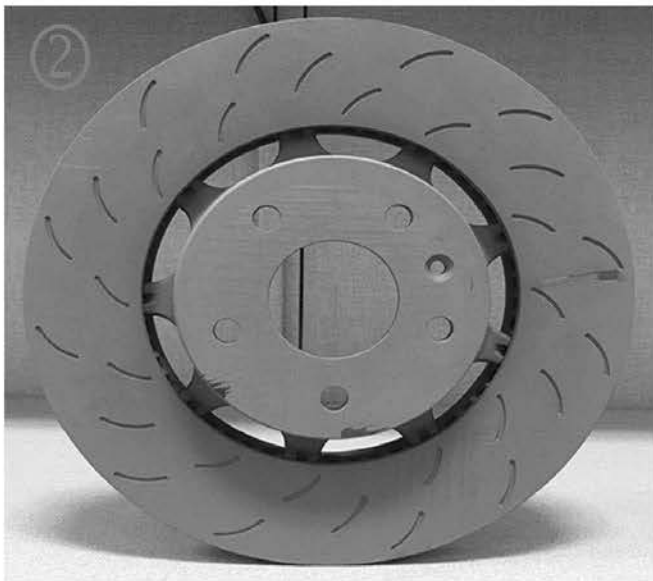
Involved Region or Country	North America and NA Export vehicles
Additional Options (RPO)	BRAKE SYSTEM-HEAVY DUTY (RPO J55)
Condition	Some customers may comment on a pulsation and/or vibration when they apply the brakes.
Cause	This condition may be due to excessive lateral runout (LRO).

Check the lateral runout:

- For front rotors and vehicles built prior to May 31, 2016, replace old two piece design (2) with new one piece design (1).
- For rear rotors and vehicles built prior to July 23, 2015, replace old two piece design (2) with new one piece design (1).

Important: The rotors **MUST** be replaced as a pair due to a design change.

Note: **DO NOT** replace all brake rotors unless you find the lateral runout out of spec for both the front and rear corners.
