Service Bulletin

Bulletin No.: 16-NA-171

Subject: Repair Information for Reconnection of Rear Window (Defroster) Contact or Tab

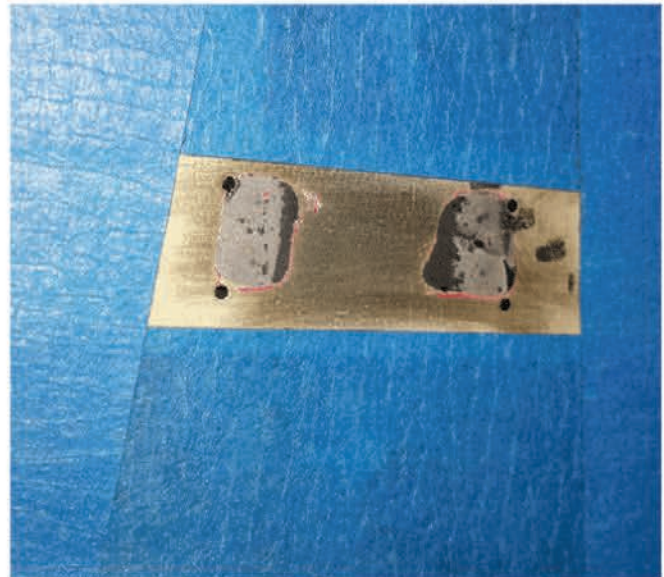
4522803

Important: Most rear glass has a black painted masking around the edge of the glass. When cleaning up the connection surface, be very careful not to damage the surface of the black shading or the surface of the glass.
