# Service Bulletin

Bulletin No.: 16-NA-178

**Subject:** Service Side Detection System Message in DIC, DTC U0232, U0233 May Be Set

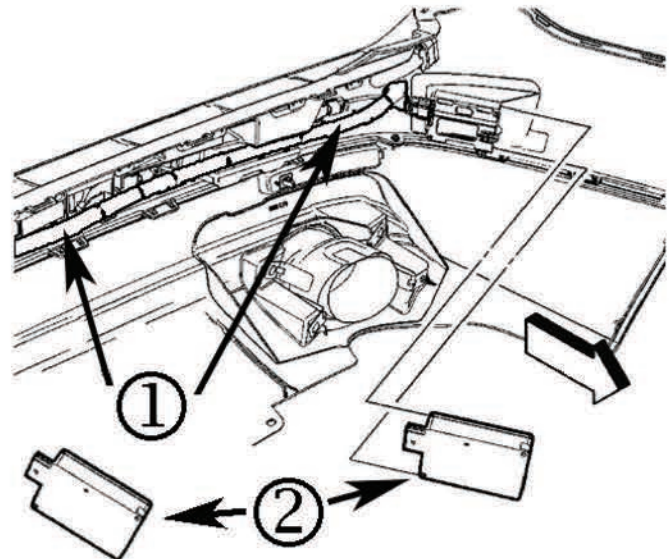
4296968

<b>Condition</b>	Some customers may comment that a Service Side Detection System message is displayed in the Driver Information Center (DIC) or DTC U0232, U0233 may be set.
<b>Cause</b>	This condition may occur with water intrusion into the Side Blind Zone Module harness connector, and may cause corrosion of the terminals or water seepage into the module.

1. Inspect the harness (1) and module (2) connectors for corrosion. If no issues are found, refer to *Side Blind Spot Alert System Malfunction* in SI.
2. If either harness or module connectors show signs of corrosion, replace the harness and both modules. Refer to *Side Object Sensing Alert Module Replacement* in SI.
