Service Bulletin

Bulletin No.: 16-NA-179

Subject: Wear Condition or Fraying of Headliner at Sunroof Module Rear Opening

Brand:	Model:	Model Year:		VIN:		Engine:	Transmission:
		from	to	from	to		
Chevrolet	Impala (VIN 1)	2014	2017			All	All

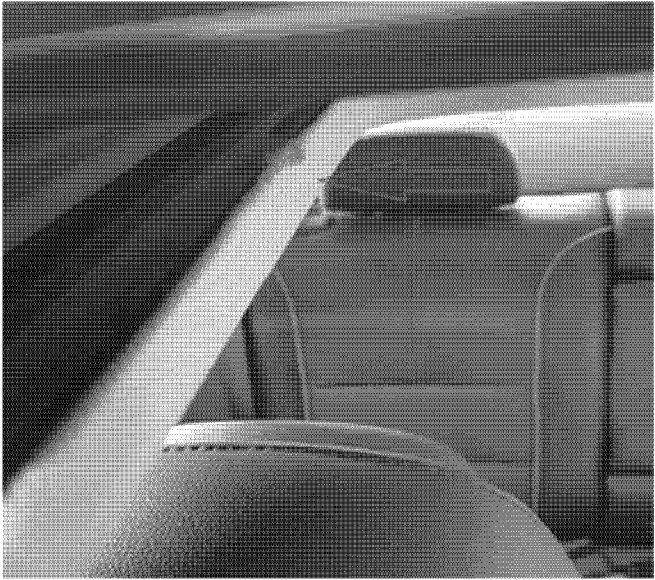
4532664

<p data-bbox="1419 749 1484 768">4532667</p> <p data-bbox="539 778 1461 853">Some customers may comment on seeing a worn area or fraying of the headliner at the sunroof module rear opening. Examples of the wear condition are shown in the graphics above.</p>
<p data-bbox="131 1221 204 1247">Cause</p>	<p data-bbox="539 868 1461 921">The cause of the condition may be due to a contact condition between the headliner and the sunroof module when cycling.</p>

For vehicles displaying the condition it will be necessary to replace the headliner, but prior to installation, also add "double" layer spacers (1) to the single lock retainer (2) at some locations on the new headliner.

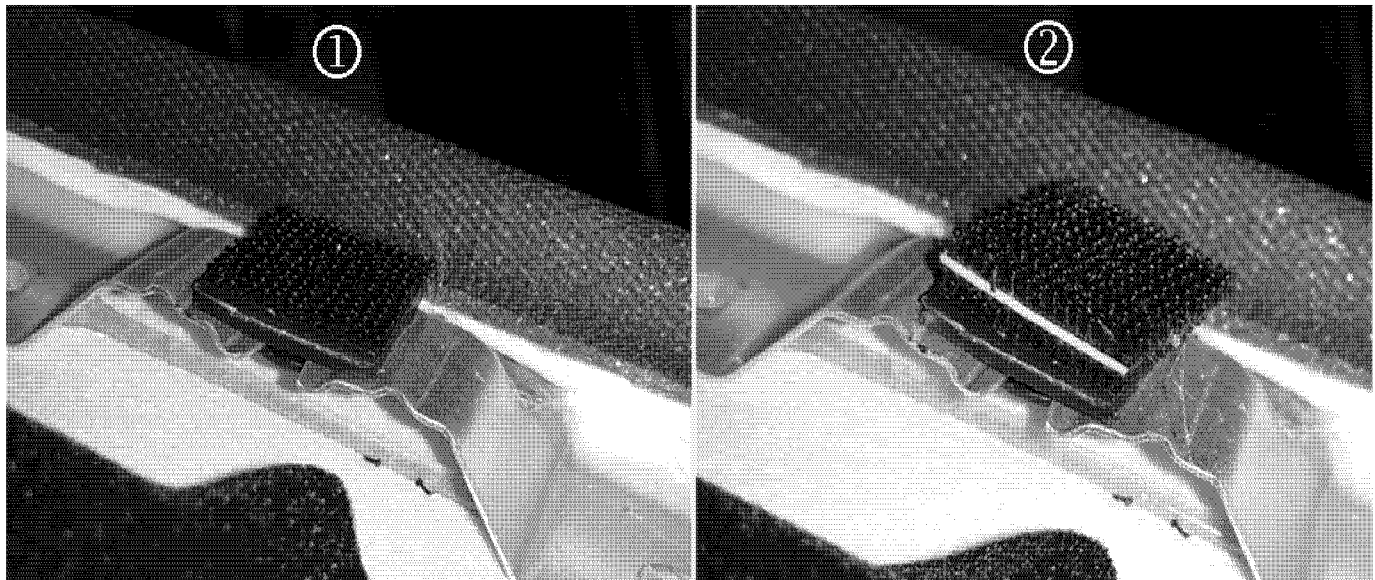
4528621

The original headliner should have contained a combination of single (1) and double (2) dual lock retainers.
