# Service Bulletin

Bulletin No.: 16-NA-185

#### Subject: Information on Front Lower Air Dam

Brand:	Model:	Model Year:		VIN:		Engine:	Transmission:
		from	to	from	to		
Buick	Cascada	2016	2016			All	All

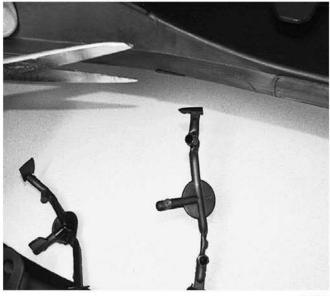
4498064

Condition	The two piece front lower air dams are placed in the vehicles trunk at the assembly plar and installed at the dealership during PDI. They were originally separate left and right side parts, but dealers will begin seeing the two halves connected.			
Cause	44906			
	As an error-proofing measure to ensure the left and right halves arrive properly, the two pieces now are attached to each other.

Using scissors, or a similar cutting tool, cut the six flat tabs at the part edge and trim any excess plastic as close to the edge as possible.
