Technical product information

Topic	Lower rearward levers ROW
Market area	Hongkong-Macau (5HK),Russische Föderation (5RU),Australia E04 Bentley rest Asia and Australia (6E04),China 796 VW Import Comp. Ltd (Vico), Beijing (6796),Germany E02 Bentley rest Europe (6E02),Japan E03 Bentley Japan (6E03),Russian Federation 935 Volkswagen Group RUS (6935),United Kingdom E01 Bentley UK (6E01),United States E05 Bentley USA and rest America (6E05)
Brand	Bentley
Transaction No.	2043080/1
Level	EH
Status	Approval
Release date

New specification front rearward lower levers are available

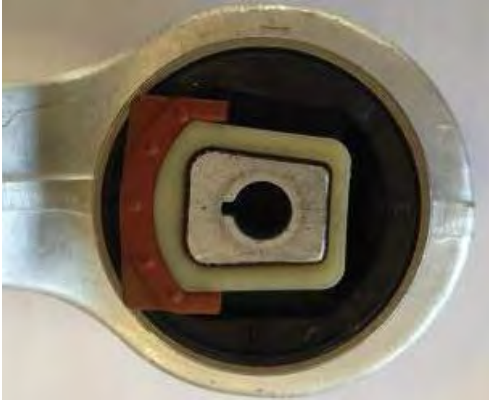
Figure 1

Figure 1, shows a lower lever with the original type bush fitted

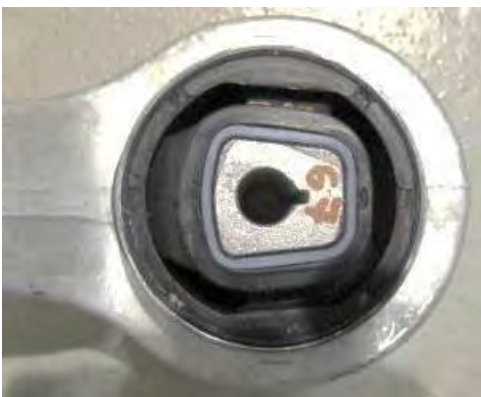
Figure 2

Figure 2, shows a lower lever with the latest specification bush fitted

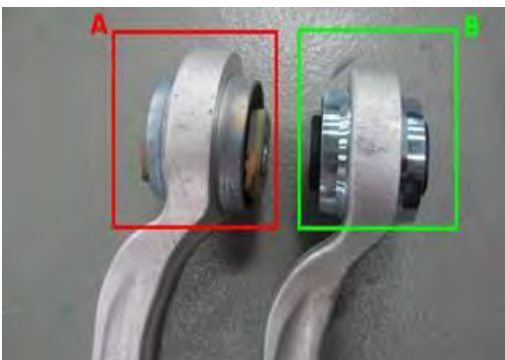
Figure 3

- Figure 3, shows the difference from the opposing side
- Point A is the original part (non tapered)
- Point B is the new specification (with tapered ends)
