Field campaign

Topic	Bentayga Electronic Parking Brake (ASW 09.02) (SC16/26)
Market area	Bentley: worldwide (2WBE),Hongkong-Macau (5HK)
Brand	Bentley
Transaction No.	2045356/1
Campaign number	EA64
Note	
Type	Service Campaign
US code

Technical background

A software timing conflict when the ignition is switched on, may result in a Diagnostic Trouble Code (DTC) being stored and a warning message displayed on the Drivers Instrument Panel when switching ignition on – 'Parking Brake: fault Contact your Bentley dealer'. DTC U040100 – Invalid data from ECM/PCM

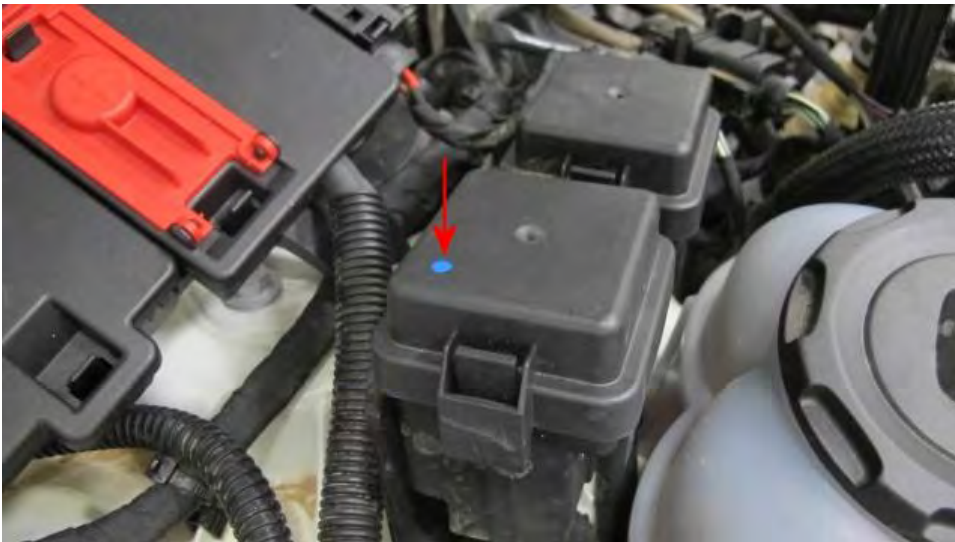
Figure 7

If the vehicle is not already listed as repaired in the "Repair history" (in Elsa Pro), check for the presence of a blue campaign completion mark on the top of the relay box adjacent to the right hand bonnet hinge (see Figure 7) should neither be evident carry out the required work in accordance with these instructions
