Service Bulletin

File in Section: -
 Bulletin No.: 16-NA-028
 Date: August, 2016

Subject: Air Conditioning Not Getting Cold Enough or Blows Warm Air

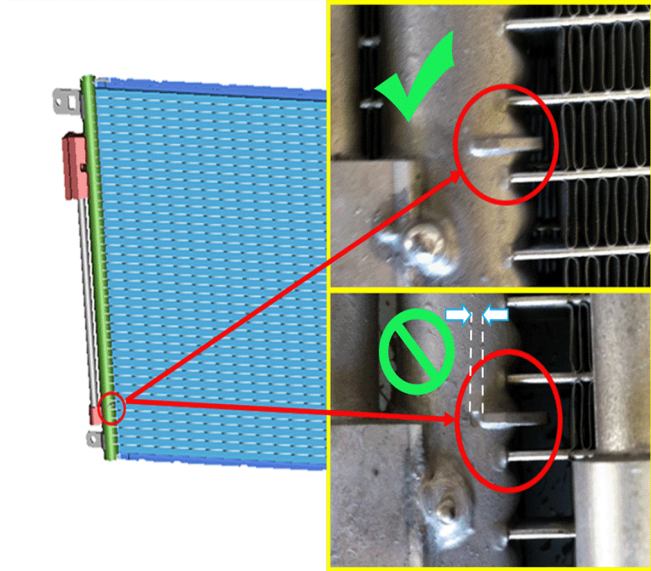
<p style="text-align: right;">4376188</p> <p>The A/C condenser supplier has found that the cause may be a block off plate that was mis-positioned during their manufacturing process. The plate may not have been fully seated prior to welding, so it may not be directing the flow of refrigerant through an area of the condenser as design intended.</p>

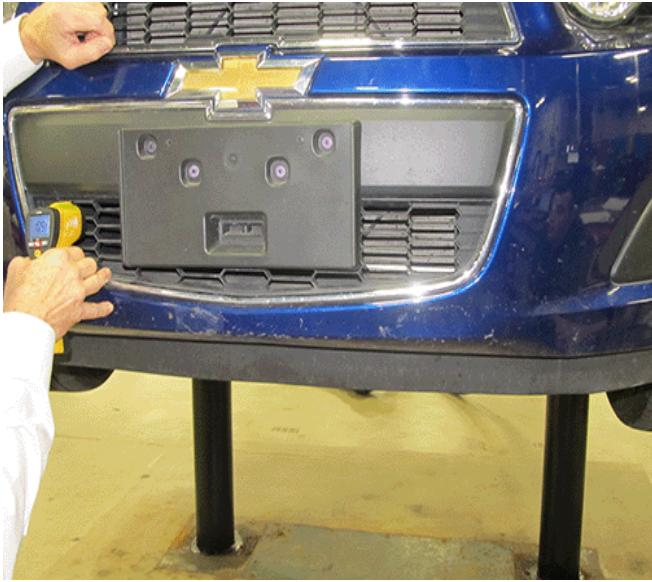
4376194

Important: Take all temperature measurements with the A/C system operating, and compressor engaged.

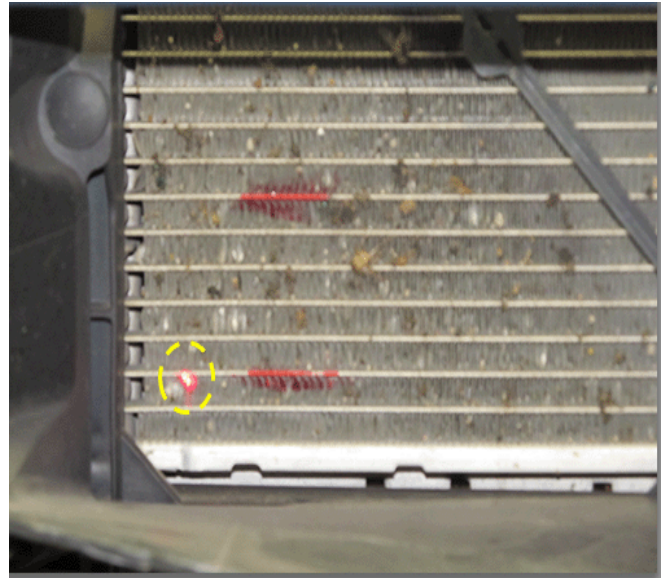
4376195

- 4.1. Take a reading at lower tube #2, designated by the lower red line in the graphic above. To obtain a proper reading, the gun beam should be positioned directly on tube #2, about 25 mm (1.0 in) to the right of the manifold.

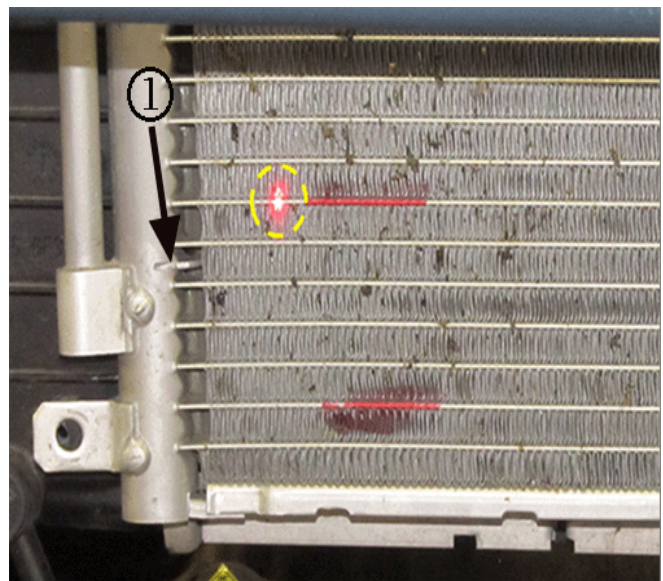
4376196

Note: The condenser air baffle has been removed in the graphic above for illustration purposes only. The intent was to show that the #7 tube is 2 tubes above the blocking plate (1).

- 4.2. Next, move the laser dot to the #7 tube (designated by the upper red line). Take a reading ensuring the beam is positioned directly on the tube, approximately the same position from the manifold.
- If the difference in the reading is at least 10 degrees F or **more**, the condenser is functioning properly and further diagnostics will need to be completed to verify the cause of the condition.
 - If the difference in the reading is approximately the same, or within 10 degrees **or less**, the vehicle has a misbuilt condenser. Prior to replacement, confirm that during temperature readings taken, the compressor was running for at least 10 seconds and was still running during measurements. If so, replace the A/C condenser. Refer to the appropriate *Air Conditioning Condenser Replacement* in SI.
