# Service Bulletin

Bulletin No.: 16-NA-043

Date: September, 2016

**Subject: Tire Pressure Monitor (TPM) Concerns After Accessory Wheel Installation**

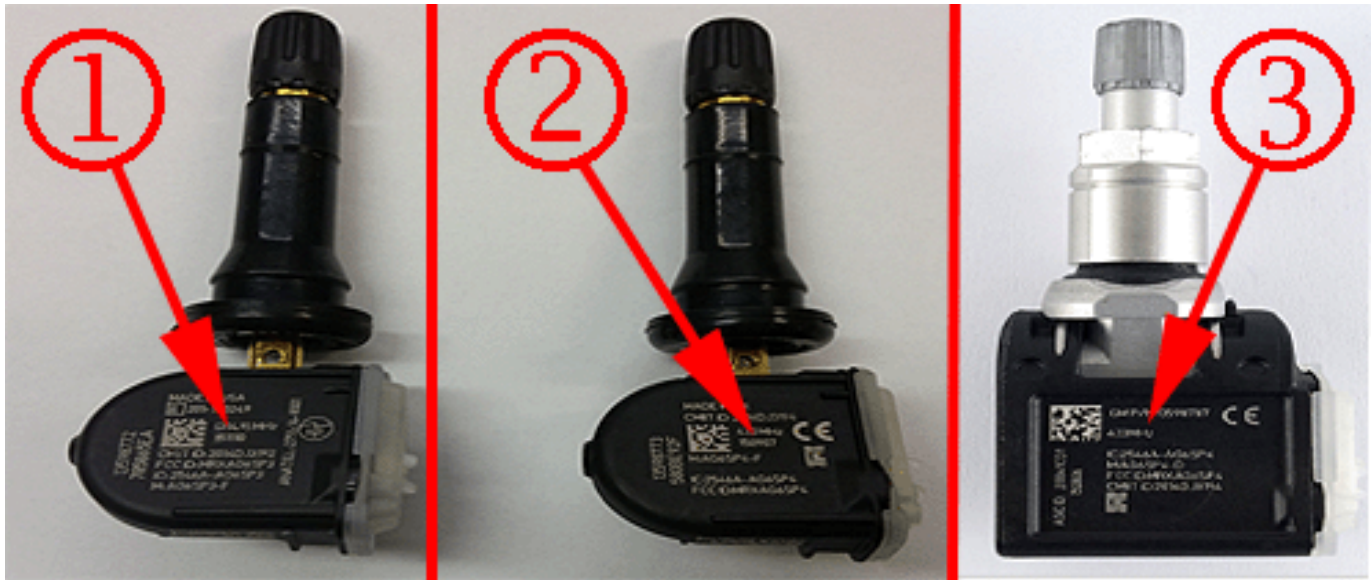
4407126

**Note:** The frequency of the sensor will be located on the sensors in the above approximate location.

Replace the sensors as needed.
