Service Bulletin

Bulletin No.: 16-NA-051

Subject: Active Shutters Inoperative, Malfunction Indicator Lamp (MIL) Illuminated

| Brand: | Model: | Model Year: | | VIN: | | Engine: | Transmission: |
|---|---|---|---|---|---|---|---|
| Chevrolet | Malibu (VIN Z) | 2016 | 2016 | | | | |

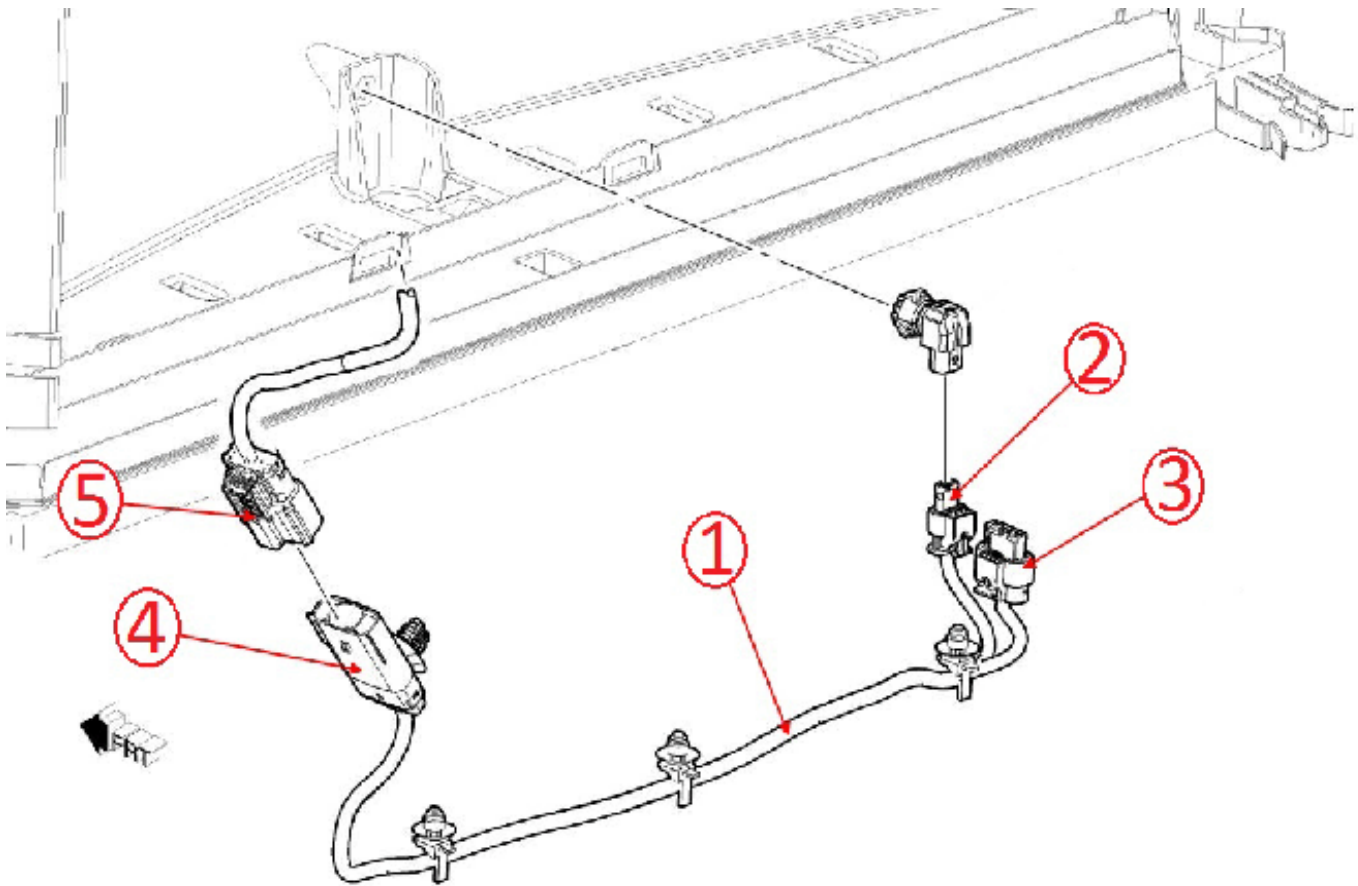
4527562

Inspect the Ambient Air Temperature Sensor Wiring Harness connectors B9 (2), M60B (3) and the X119 (4, 5) for any signs of corrosion.

- If any corrosion was found on the Ambient Air Temperature Sensor Wiring Harness (1), it must be replaced.
- If the corrosion was found at the X119 connector (5), the main body wiring harness connector must be repaired as needed.
- If the corrosion was found on the B9 connector (2), the Ambient Air Temperature Sensor must be replaced.
- If the corrosion was found on the M60B connector (3), the active shutter must be replaced.
