Service Bulletin

Bulletin No.: 16-NA-078

Subject: Rattle Noise from Manual Transmission Shifter

Brand:	Model:	Model Year:		VIN:		Engine:	Transmission:
		from	to	from	to		
Chevrolet	Camaro	2016	2017				All Manual

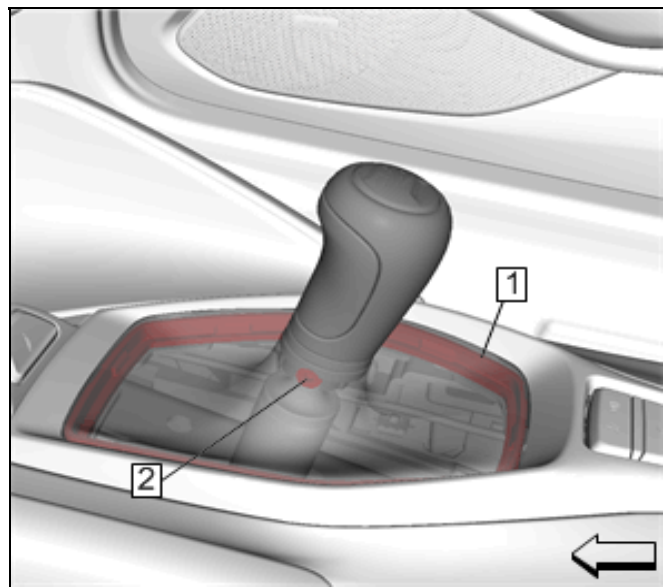
4177183

Involved Region or Country	North America and N.A. Export Regions
Condition	Some customers may comment that the shifter knob is rattling.
Cause	This condition may be caused by a loose shifter knob retaining screw.

1. Using a flat-bladed trim tool, detach the transmission control lever boot (1) from the console.
2. Lift the transmission control lever boot to access the shift knob fastener (2).
3. Remove the fastener.
4. Apply thread locker, GM P/N 19333511 (In Canada, use 10953489), to the shift knob fastener and install.

Tighten the fastener to 9 N•m (80 lb in).

5. Install the transmission control lever boot to the console.
