Service Bulletin

Bulletin No.: 16-NA-118

Subject: Engine Wiring Harness Chafing, No Start or Malfunction Indicator Lamp (MIL) ON

ſ	Brand: Model:		Model Year:		VIN:		Engine:	Transmission:
	Dianu.	woder.	from	to	from	to		
Ī	Chevrolet	Sonic	2013	2016			LUW, LWE	All

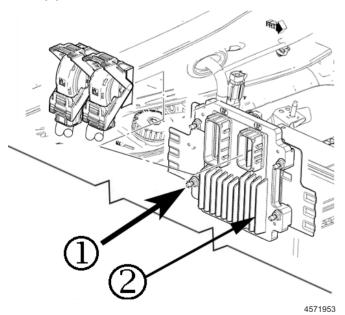
Condition	Some customers may comment on various conditions such as; no start, Malfunction Indicator Lamp (MIL) ON, and possible loss of steering assist.	
Cause	Technicians may find the engine harness routed too close to the ECM lower mounting bracket stud or the corner of the ECM. The stud or corner can pierce the harness, and chafe and short wires inside the harness.	
Additional Options	Equipped with 1.8L L4 LUW or 1.8L L4 LWE engine

ECM Mounting Bracket Stud (1) and Corner of ECM (2) Contact Area

Inspect the harness for signs of contact or damage. Reroute or repair as necessary.
