<b>HYUNDAI</b>   NEW THINKING. NEW POSSIBILITIES.  <b>Technical Service Bulletin</b>	GROUP <b>HYBRID CONTROL</b>	NUMBER <b>16-HC-001</b>
	DATE <b>MAY 2016</b>	MODEL <b>SONATA HYBRID (LF HEV)</b>
<b>SUBJECT:</b> HYBRID ELECTRIC VEHICLE - OIL LEAK AT ELECTRIC OIL PUMP

**Description:** On some Sonata Hybrid (LF HEV) vehicles, a small oil leak may occur from the electric oil pump (EOP) seals.

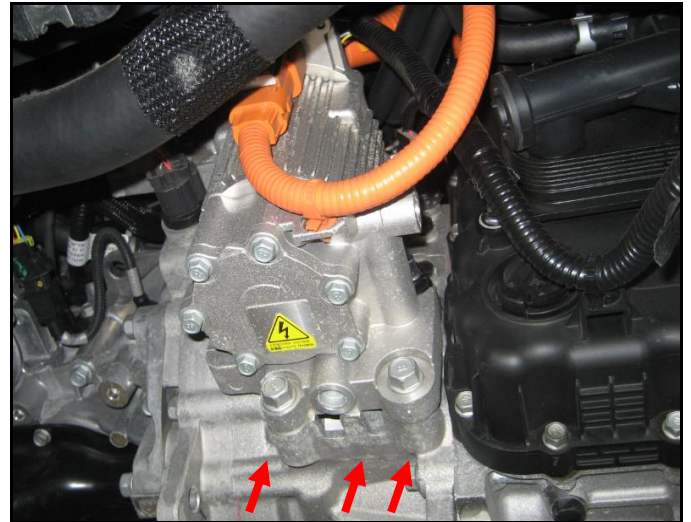
6. Locate the EOP near the oil pan.

Check for a small oil leak between the EOP and the transmission at the base of the EOP. If so, go to step 7.
