HYUNDAI NEW THINKING. NEW POSSIBILITIES.	GROUP	NUMBER
	CAMPAIGN	16-01-018-2
Technical Service Bulletin	DATE	MODEL(S)
	MAY 2016	VARIOUS 14MY
SUBJECT: 14MY BASE AUDIO SOFTWARE UPDATE (SERVICE CAMPAIGN TBB)

DESCRIPTION: This bulletin describes the procedure for updating the Bluetooth and Voice Recognition software for certain 2014 Model Year Audio systems.

**Service Procedure: Base Audio [NON Color Touch Screen]
Bluetooth and Voice Recognition Software Update**

**Service Procedure: Base Audio Small Color Touchscreen
Bluetooth and Voice Recognition Software Update**

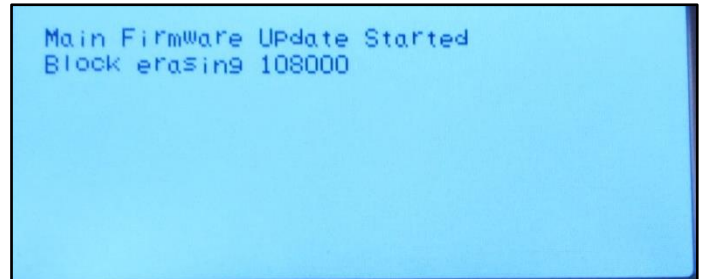
8. The Main Firmware Update will take approximately 3-5 minutes.

If the audio unit does not turn off within 5 seconds of resetting, the update has failed.

Retry update using step (4).

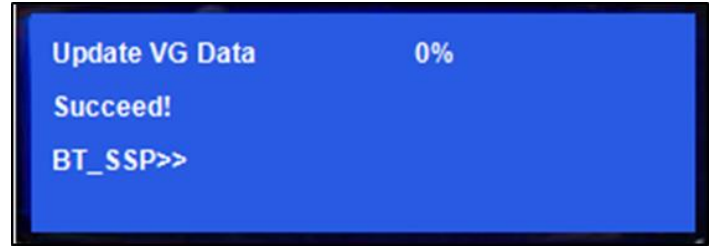
14. If the Update Failed message shown to the right is ever displayed during the update, the contents of the USB may have become damaged.

Please contact Hyundai Techline for assistance. **1-800-325-6604**
