Service Bulletin

File in Section: -
 Bulletin No.: 16-NA-123
 Date: September, 2016

Subject: Cooling Fan Inoperative, Malfunction Indicator Lamp Illuminated and/or DTCs P0480, P0691, P0CED, P1F44 Set

Brand:	Model:	Model Year:		VIN:		Engine:	Transmission:
		from	to	from	to		
Chevrolet	Malibu (VIN Z)	2016	2016			All	All

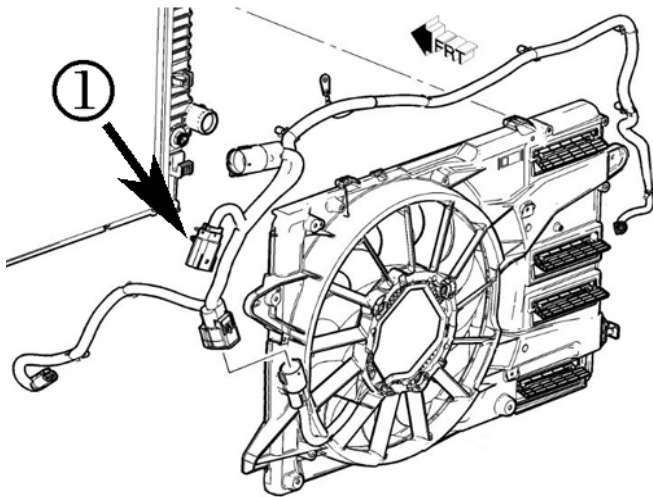
4452764

Involved Region or Country	North America and Israel
Condition	Some customers may comment that the Malfunction Indicator Lamp (MIL) is illuminated. Technicians may find one or more of the following DTCs set: <ul style="list-style-type: none"> • P0480 • P0691 • P0CED • P1F44
Cause	Upon inspection, technicians may find water intrusion in the X117 cooling fan connector.

Cooling fan harness connectors (1) are to be inspected. The harness connector on the engine side is to be cleaned if possible, and the cooling fan jumper harness should be replaced if needed.
