Service Bulletin

Bulletin No.: 16-NA-173

Subject: Exhaust Rattle Noise Originating from Rear of Vehicle

Brand:	Model:	Model Year:		VIN:		Engine:	Transmission:
		from	to	from	to		
Chevrolet	Camaro	2016	2017			LT1 or LGX	All

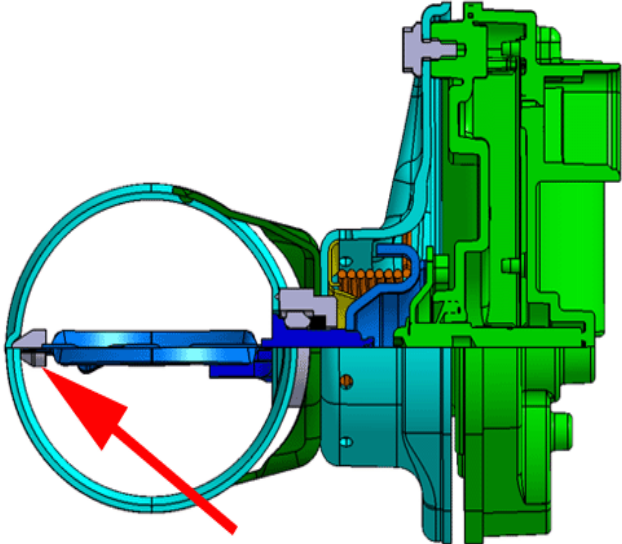
<p style="text-align: right;">4508506</p> <p>This may be caused by the ceramic pin on the exhaust valve.</p>

Involved Region or Country	North America, Europe, Israel, Middle East, Korea
Additional Options (RPO)	Equipped with Performance Exhaust RPO NPP
Condition	Some customers may comment on an exhaust rattle originating from the rear of the vehicle.
Cause
