Service Bulletin

Bulletin No.: 16-NA-205

Subject: Blu-Ray Movies Do Not Start After Play Icon Selected On Menu

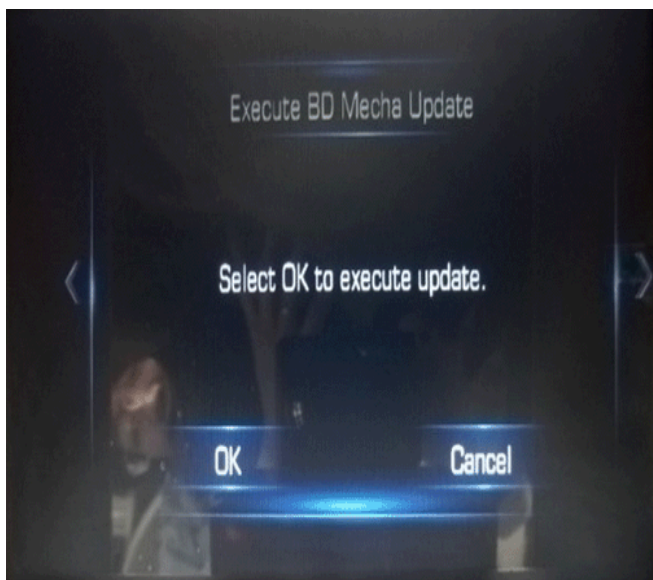
4560467

Remove any media in the Media Disk Player and insert the update disk in the Media Disk Player, which is located in the instrument panel or in the glove box. Once the Update Disc has been inserted, the popup shown above will appear on the rear display(s).

Select OK by highlighting the button with the remote control and hitting enter. After a short time, the Update Disc will automatically eject. REMOVE the disk.

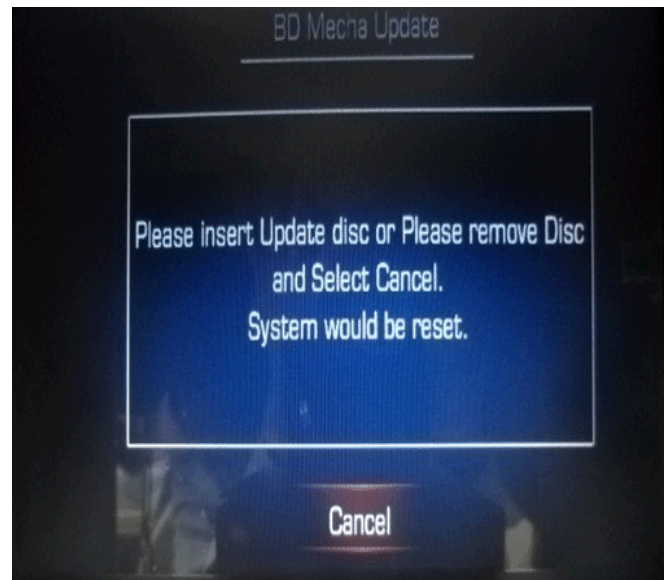
4560468

The following screen will be shown on the rear display(s). Re-insert the same Update Disc. Do **NOT** select "Cancel."

WAIT for the files to be copied. Do NOT turn the power off. Do NOT touch the system until the disk ejects automatically in about 20 minutes. Once the disk ejects remove the disk. After the disk has been removed, the update process will continue for a couple more minutes.

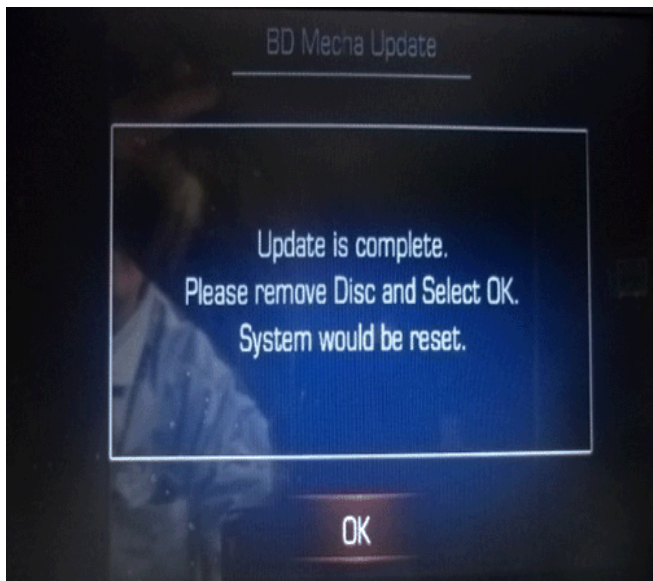
4560469

When the update process has finished, the message shown above will appear on the rear display(s).

Select OK with the remote control by pressing enter and the Media Disk Player will restart automatically.

After the Media Disk Player restarts, press the menu button on the remote control, select software information, and then select version. In the "Other Micros" section verify that B/E = 06/01/16 and F/E = 03/12/14.
