Service Bulletin

File in Section: -
Bulletin No.: 16-NA-239
Date: August, 2016

Subject: Information on Enabling 4G LTE Wi-Fi Hotspot on New Vehicle

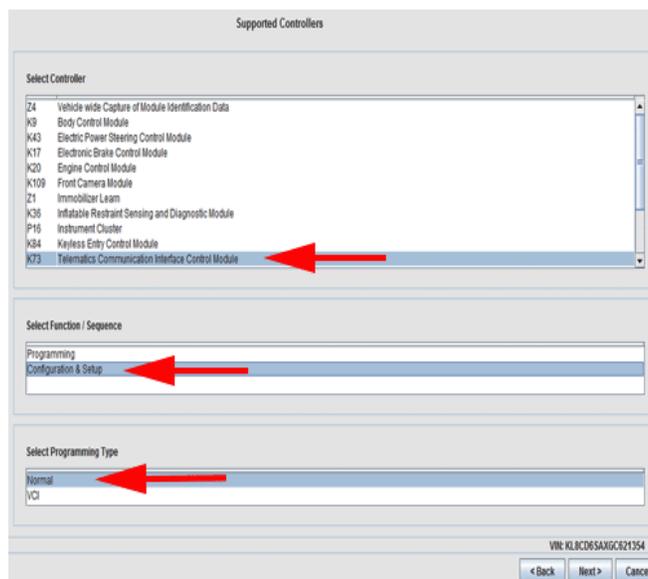
4564321

Note: 2016 Chevrolet Spark shown, other vehicles similar.

4. As shown above, select K73 Telematics Communication Interface Control Module as the Controller Type, Configuration & Setup as the Function/Sequence, and Normal as the Programming Type before selecting Next.
5. Following remaining TIS2web on-screen instructions to enable Wi-Fi.
6. Once complete, disconnect the negative battery cable.
