HYUNDAI NEW THINKING. NEW POSSIBILITIES.	GROUP CAMPAIGN	NUMBER 16-01-022-1
	DATE MAY 2016	MODEL(S) ELANTRA 2.0L (ADa)

Technical Service Bulletin

SUBJECT: A/C SUCTION & LIQUID TUBE REPLACEMENT
(SERVICE CAMPAIGN TEE)

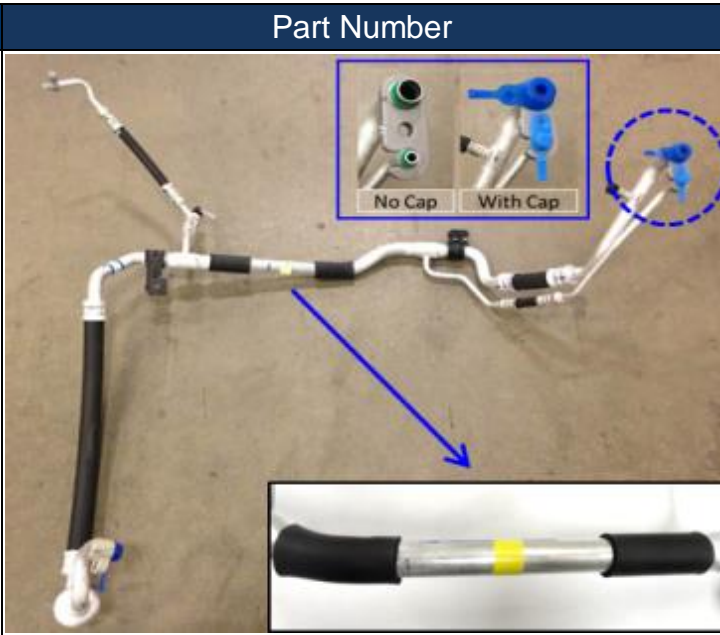
<p>New campaign parts can be identified with a YELLOW colored tape wrapped at the middle of the tube assembly.</p> <p>In addition, the connection points to the thermal expansion valve (TXV) and the condenser may have protection caps. Any caps must be removed during assembly.</p>
	97774-F2100QQH

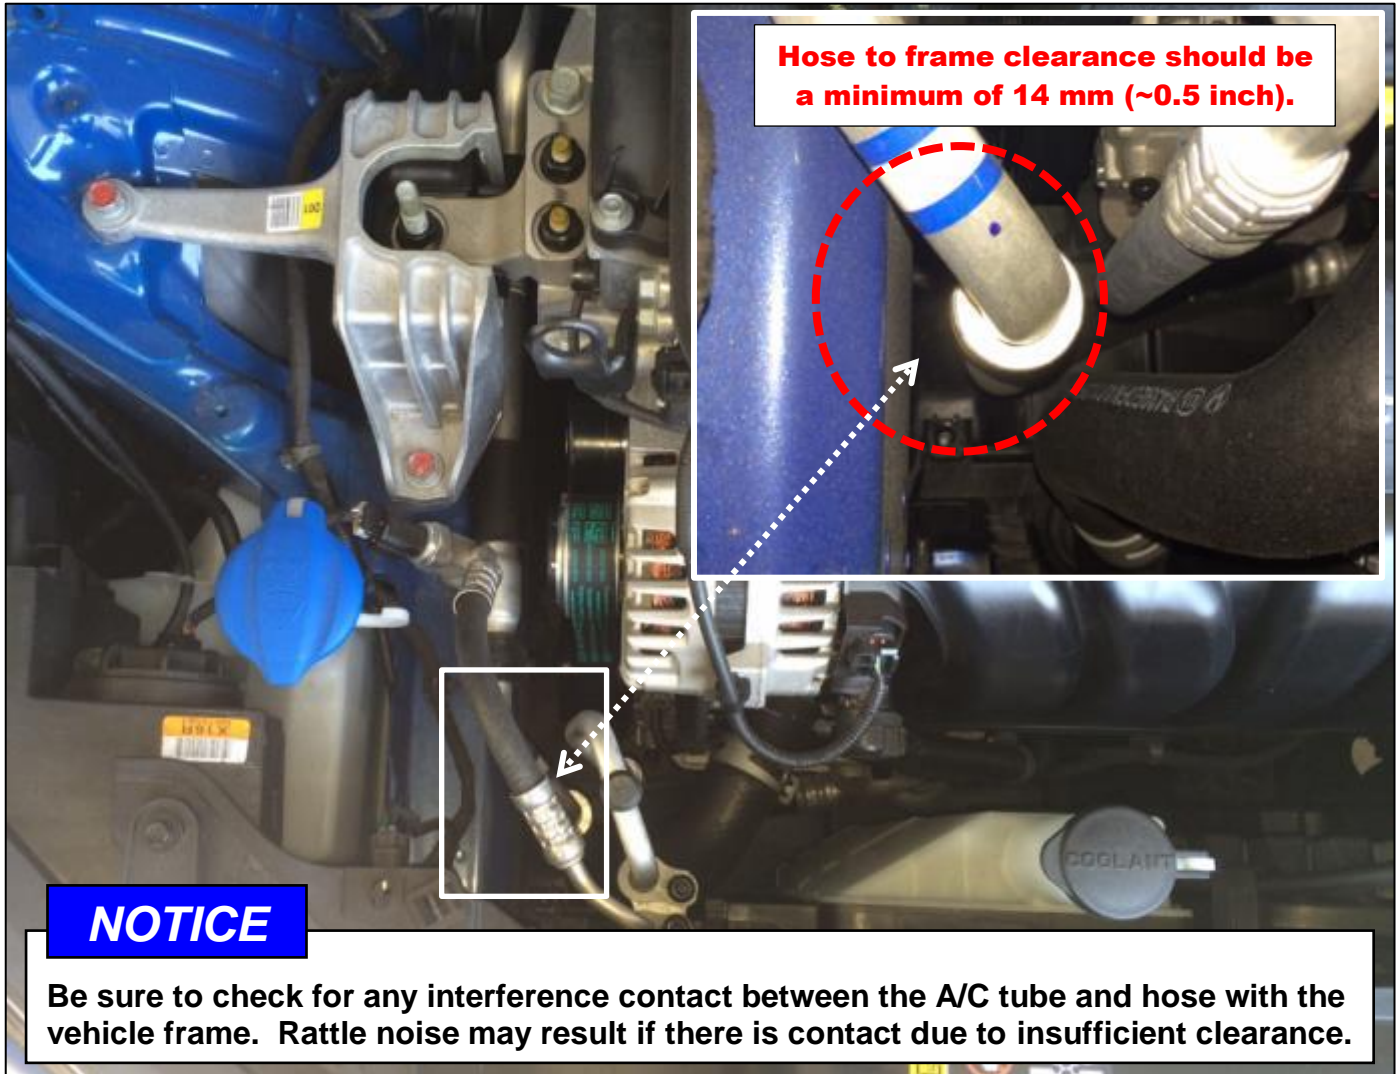
Be sure to check for any interference contact between the A/C tube and hose with the vehicle frame. Rattle noise may result if there is contact due to insufficient clearance.

13. Install the new suction and liquid pipe in the reverse order of removal.

- **Ensure that the new suction and liquid pipe is positioned properly in the mounting bracket.**
 - **Ensure O-ring seals are installed and do not get pinched when installing.**
 - **Check for proper isolation so that it is not touching any part of the body structure.**
 - **Check for interference and sufficient clearance with any moving components inside the engine compartment.**
