# Service Bulletin

Bulletin No.: 16-NA-245

**Subject:** Rear Cargo Area Left Hand Second Row Seat Difficult or Will Not Release

Brand:	Model:	Model Year:		VIN:		Engine:	Transmission:
		from	to	from	to		
GMC	Acadia (VIN N)	2017	2017			All	All

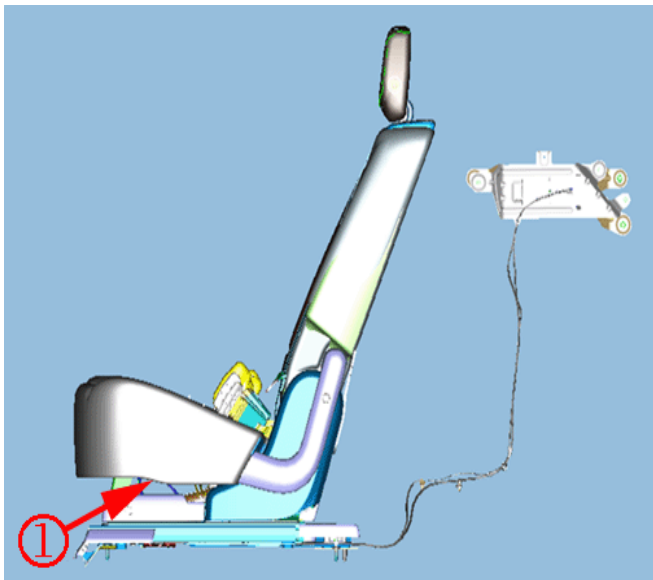
4563488

<b>Involved Region or Country</b>	North America and Middle East
<b>Condition</b>	Some customers may comment that the rear cargo area left hand 2nd row seat release handle doesn't release seat, or requires too much effort to release.
<b>Cause</b>	This may be due to the cable in need of adjustment.

1. Ensure that the 2nd row seat is in the upright position and both recliners are fully locked.
