## **Service Bulletin**

Bulletin No.: 16-NA-246

**Subject: Information on Airbag Warning Lamp Illuminated**

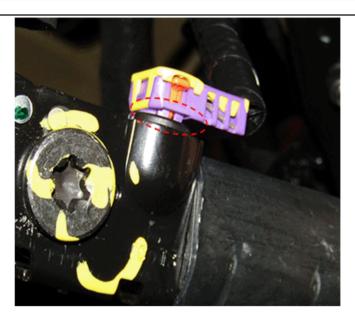
4561491

The cause of the condition may be an airbag warning lamp connector, which may be loose or not fully seated. An example is shown in the graphic above.
