**HYUNDAI**

## Technical Service Bulletin

**16-01-039**

**SUBJECT:** 2013 ELANTRA (MD/UD) BRAKE PEDAL STOPPER REPLACEMENT  
(RECALL CAMPAIGN 146)

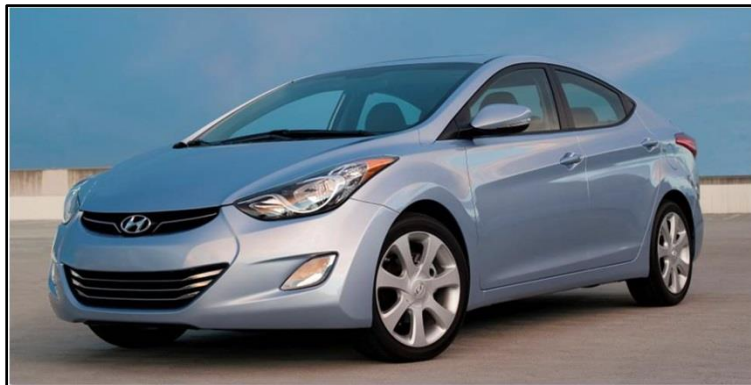
**Description:** The brake pedal stopper pad is located between the stop lamp switch and the brake pedal arm. The brake pedal stopper pad material in the affected vehicles can deteriorate allowing the stop lamp switch plunger to remain extended when the brake pedal is released. A deteriorated pad can result in the stop lamps illuminating continuously, illumination of the traction control warning lamp, the ability to move the shift lever without depressing the brake pedal, or activation of the engine management system's brake pedal override feature.

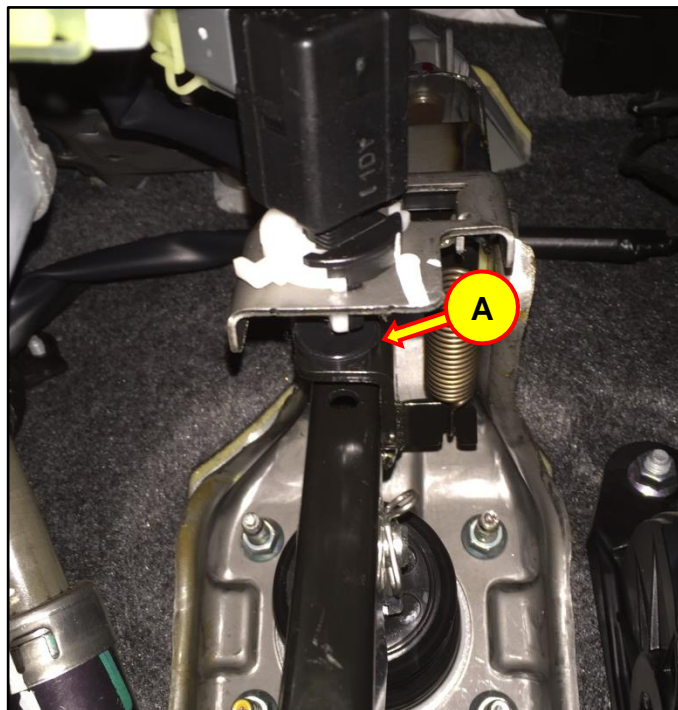
4.        The stopper (A) is mounted on the brake pedal, in-line with the stop lamp switch.
