Service Bulletin

File in Section: -
 Bulletin No.: 16-NA-250
 Date: August, 2016

Subject: Slow Cranking, Dead Battery and/or No Start

Brand:	Model:	Model Year:		VIN:		Engine:	Transmission:
		from	to	from	to		
Chevrolet	Corvette	2014	2016	-	-	LT1, LT4	-

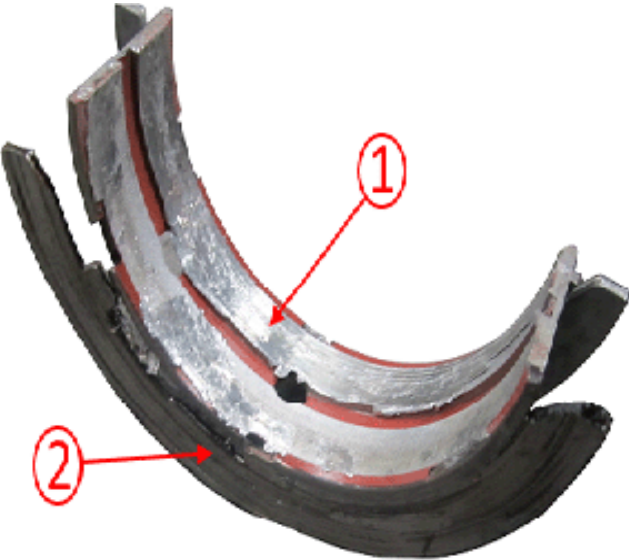
</div> <p style="text-align: right; font-size: small;">4567041</p> <p>This may be caused by excessive pressure to the engine crankshaft thrust bearing (1), by forward pressure from a mis-aligned driveline support assembly.</p>

If the driveline support assembly has been removed from a previous vehicle repair, it is required that the propeller shaft hub clamp (Automatic Transmission) or input shaft front bearing (Manual Transmission) be realigned. Follow the procedures outlined in SI.
