# Service Bulletin

File in Section: -  
 Bulletin No.: 16-NA-270  
 Date: August, 2016

**Subject: Creak/Rattle/Clunk Over Bumps in Left or Right Rear Package Shelf Area**

Brand:	Model:	Model Year:		VIN:		Engine:	Transmission:
		from	to	from	to		
Buick	Cascada	2016	2016			All	All

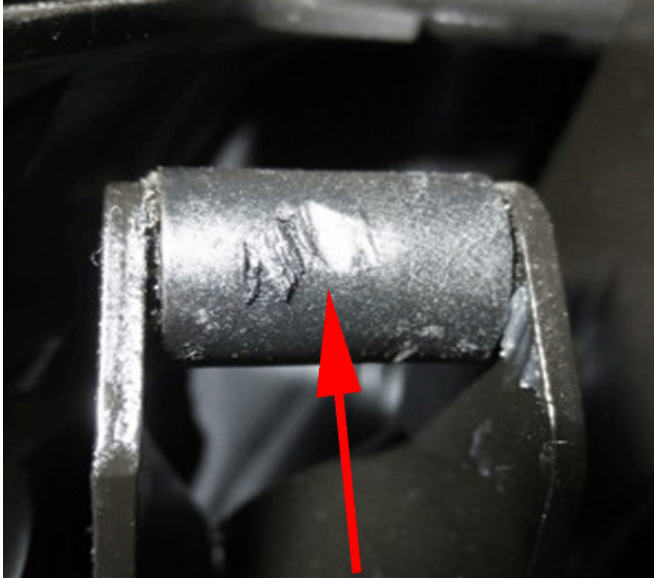
<p style="text-align: right; font-size: small;">4551288</p> <p>This may be due to the folding top stowage compartment cover guide rollers not rolling freely causing wear on top and/or bottom of the roller. When roller is worn, this causes excessive gap between the roller and guide forks on the front of the stowage compartment lid, allowing it to clunk or rattle up and down.</p>

If you encounter a vehicle with the above concern, replace the stowage compartment lid bumper bracket which includes the roller. Refer to *Folding Top Stowage Compartment Lid Bumper Bracket Replacement* in SI.

**Important:** Make sure the roller rolls freely and apply some Vaseline or equivalent to the roller.
