NOx Sensor Report – Contamination at Contact Portion (Talc)

PRAS 119531; Ticket 15G09661AA

Customer PN: 68197109AA Conti PN: 5WK96799 SN: 15032504496799 01 NOx Sensor Version: Gen2.5 CQTS: 300001137901-20

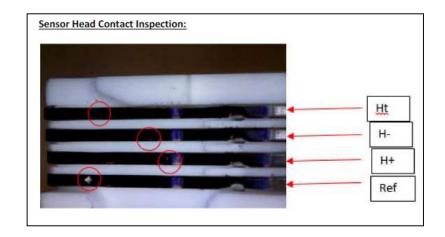
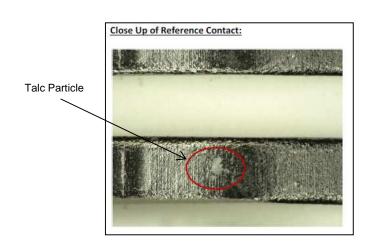
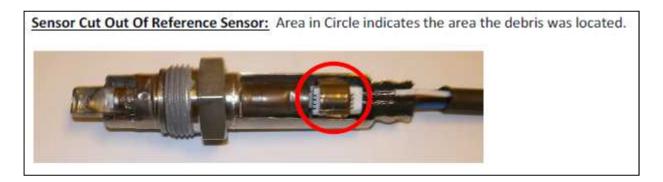
Sensor Head Evaluation and Talc Particle

Supplier detected particle contamination at contact portion (talc) on female contact between contact and element pad.

Talc particles are inherent in the production environment as talc is a necessary part of the sensor product.

Talc is a low ppm occurrence; continuous improvement actions control talc particles.
