Service Bulletin

Subject: Front Sunroof Sunshade Will Not Latch or is Difficult to Latch in the Closed Position

Models: 2010-2017 Buick Enclave
2010-2017 Chevrolet Traverse
2010-2016 GMC Acadia
2017 GMC Acadia Limited
2010 Saturn OUTLOOK
Equipped with Sunroof RPO C3U
and Built After August 1, 2009

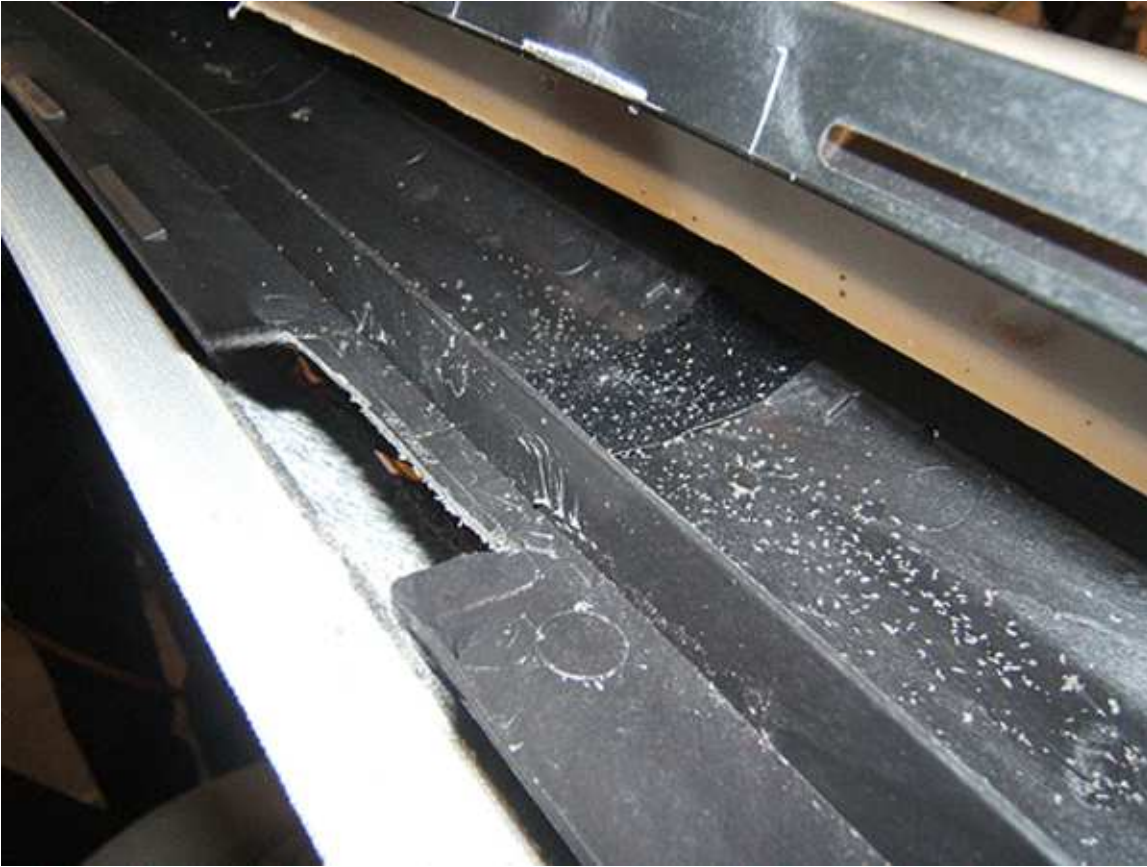
Some customers may comment that the front sunroof sunshade will not latch in the closed position.
The molded-in sunroof sunshade striker on the sunroof module may be broken.

Replace the front sunroof sunshade striker with the service replacement striker by riveting it to the sunroof module assembly.

1. Check that the sunroof sunshade striker fits into where the broken striker was by placing the sunroof sunshade striker under the bottom of the front rail. File to fit if necessary.
2. Place the sunroof sunshade striker on the top surface of the front rail to locate the holes. Mark the hole locations.

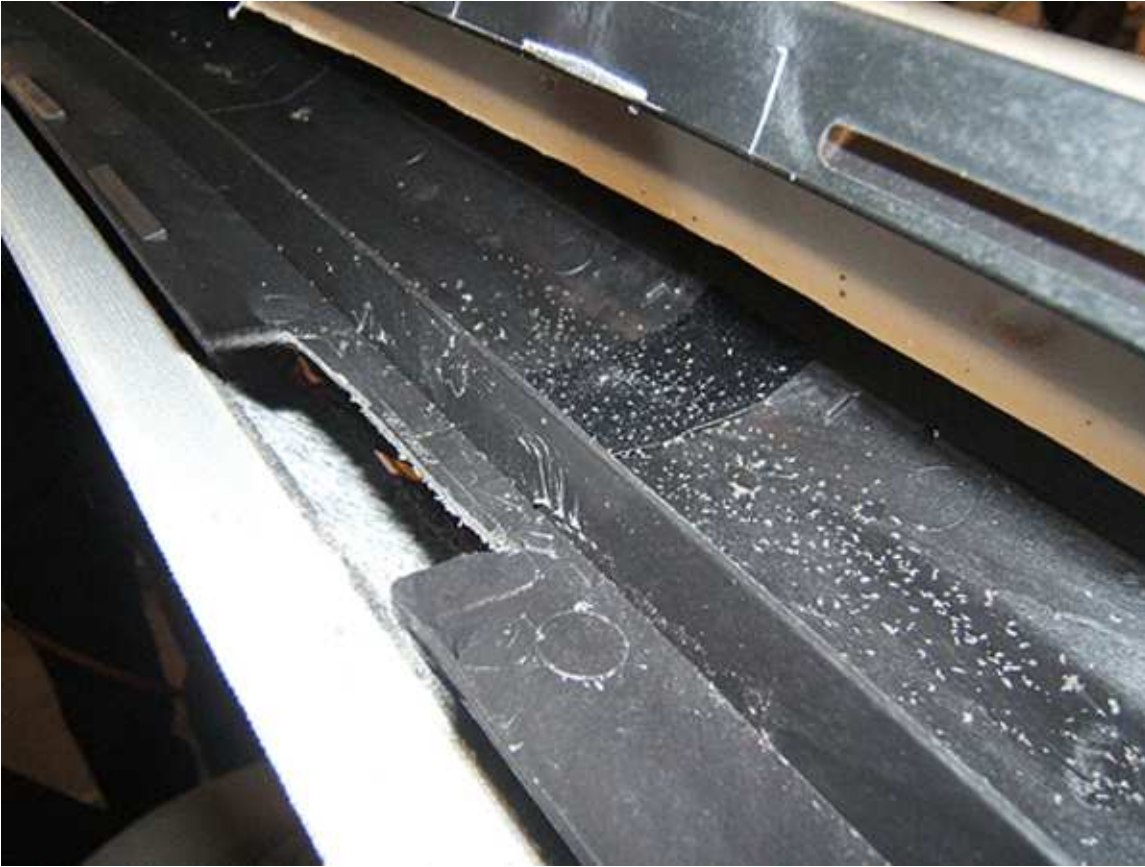
Some customers may comment that the front sunroof sunshade is difficult to latch in the closed position.

The front rail of the sunroof module may sag due to high ambient temperatures causing the sunshade striker to sit lower. This is more prevalent on dark colored vehicles when parked in direct sunlight for an extended period of time.

Remove the existing molded-in sunroof sunshade striker and install the service replacement striker by riveting it to the sunroof module assembly.

Important: When removing the striker, be careful not to cut/damage the headliner.

1. Remove the existing sunshade striker using a Dremel or similar tool.
2. Place the sunroof sunshade striker on the top surface of the front rail to locate the holes. Mark the hole locations.
