Service Bulletin

Subject: Remove Flocked Material from Front Side Door Interior Trim Panel During PDI

Models: 2013-2017 Buick Enclave

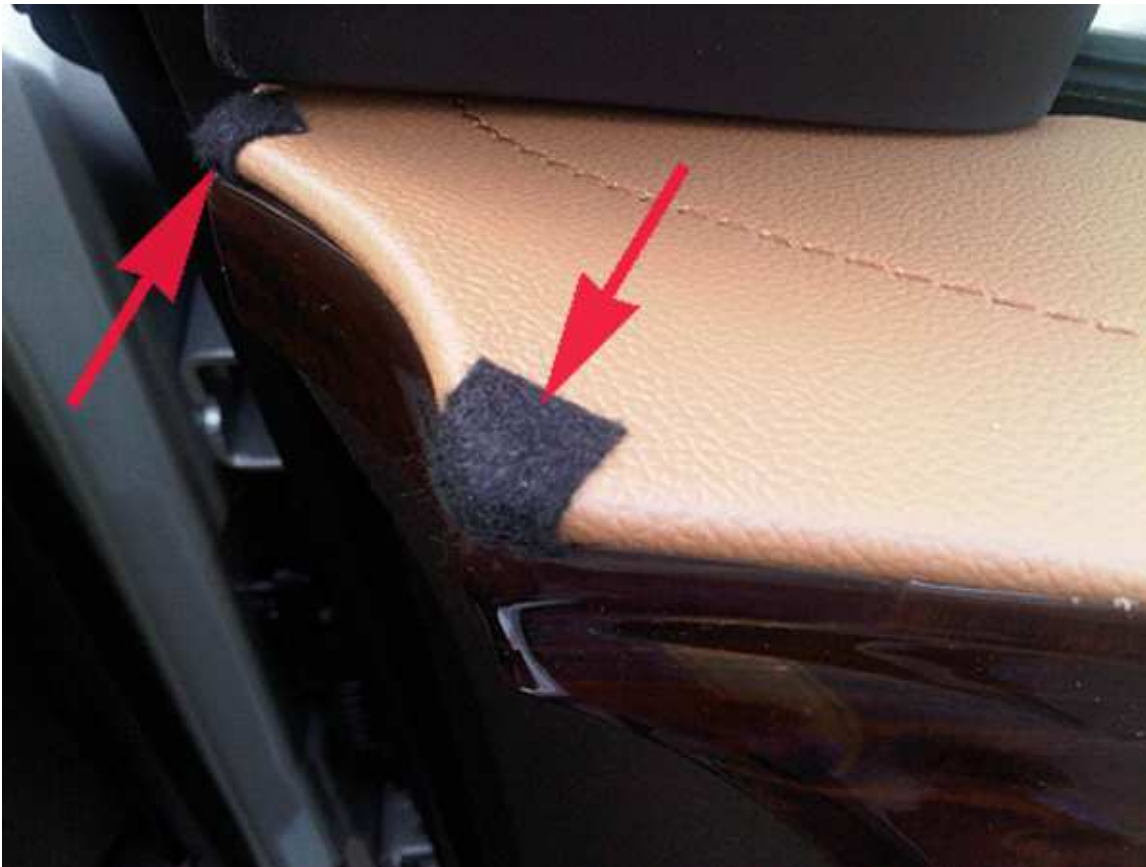
Two pieces of adhesive backed flocking material (black felt) are installed on the front side door interior trim panels as shown. This material is installed to protect the door panels during the build process.

Remove the flocking material from both front side door interior trim panels during the Pre Delivery Inspection (PDI).

Clean any adhesive residue from the trim panel. Use care to not damage the finish. For information on proper interior cleaning products, refer to the latest version of Bulletin Number 06-00-89-029.
